RESTORATION OF A XVI CENTURY FARM HOUSE IN SUFFOLK.

(Swan Green, Craftfield)

By ARTHUR WELFORD, A.R.I.B.A.

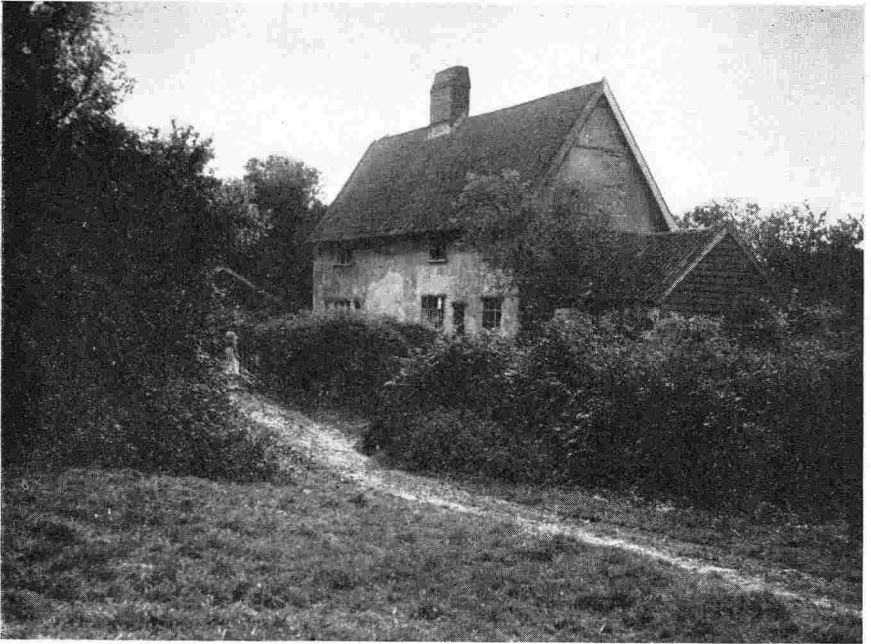
PLATE I.

Plate I and Figs. 1 and 2 show the house as it was in 1938. The roof, though sound as to main timbers, was dilapidated in detail. The timber and clay walls had been repaired with brickwork in places, at no distant date, and there was a settlement of the old brick foundations along the SW side. The S angle post and part of the base plate were rotten. The clay panels were a good deal decayed and had slipped in many cases, letting in the daylight; and the exterior plaster was loose in some places and patched in cement in others. No original doors or windows appeared on the exterior, though there were indications of XVI century windows in the NW gable and on the SW side. (Fig. 2.)

The house as it was in 1938.

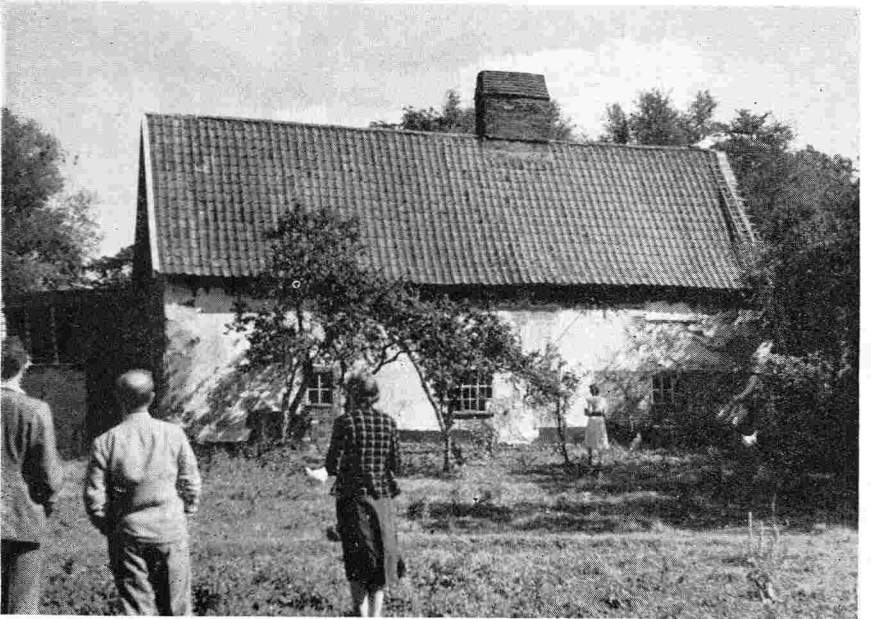
The roof partly repaired.

The work of restoration was begun by repairing the roof; Plate I shows this partly done.

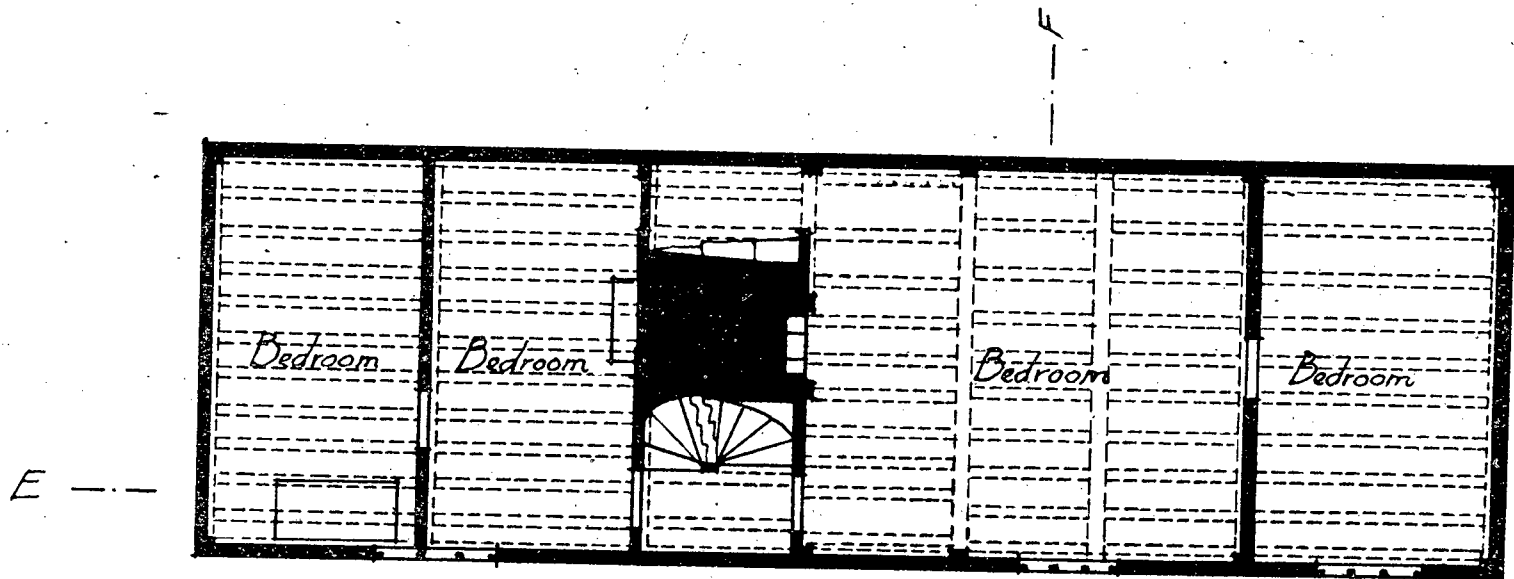
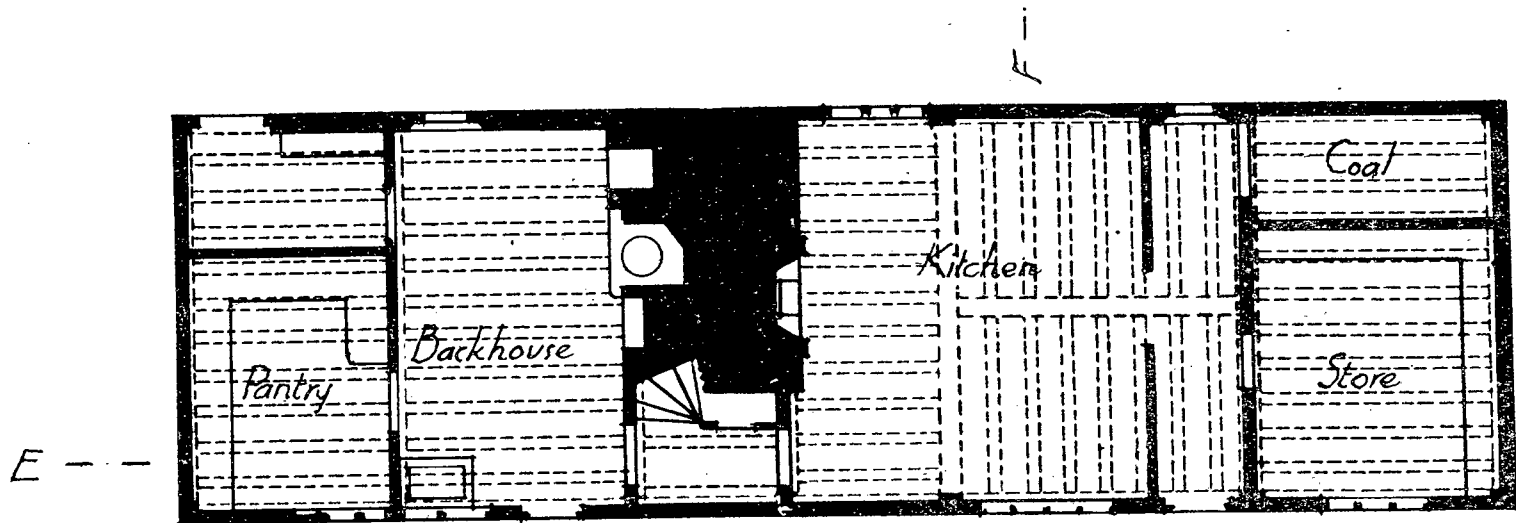
FIG. 1.

Internally. Modern partitions in the old Parlour were removed. The screen across the Kitchen (Fig. 1) is of pine, panelled, and is of XVIII century date; it was retained as being a pleasant and useful feature. The partition across the Parlour Chamber was removed.

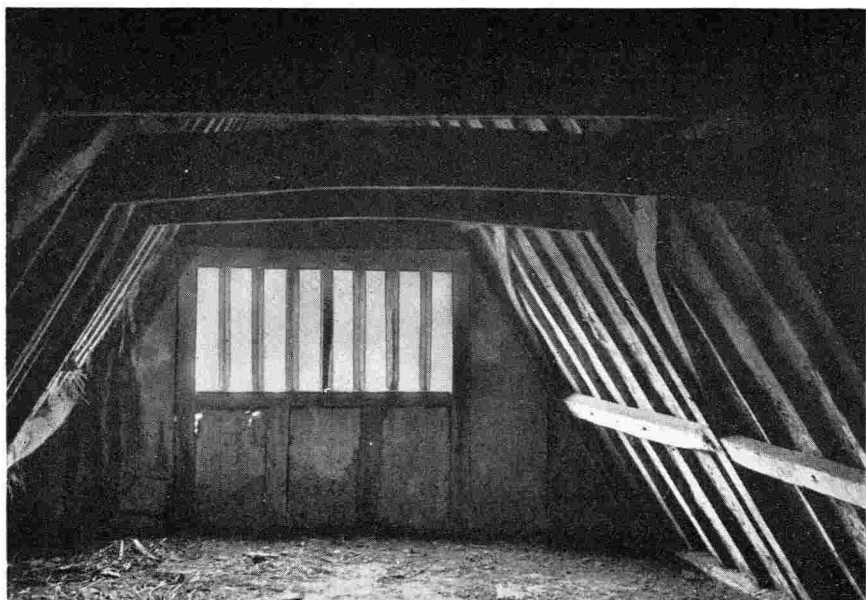
PLATE II.

The problem as to the exact form of the original windows was solved in a fortunate manner. In taking out the clay fillings, inside and outside, several of the glassless type of window were revealed; these windows were formed of oak mullions about $2\frac{1}{2}$ in. to 3 in. square, set diagonally, and about 5 in. to 6 in. apart. (Plate II.) Then, in taking out the fillings in the SE end of the building several fragments of old window frames were found, wedged into the openings to form a foundation for the clay filling. Parts of mullions, transome, head, and sill were found; these were measured, together with mortices in sill and head, and a drawing was made. It was found that this detail exactly suited the old openings, and the new frames were made accordingly and fitted with leaded glazing and opening casements. (Plate II.)

Glassless type of window.

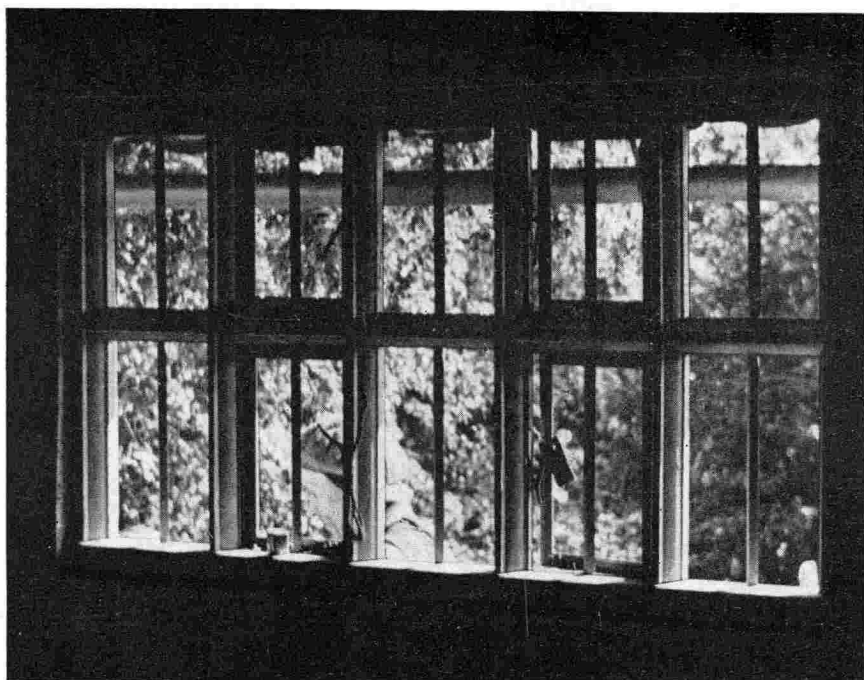
The new windows.

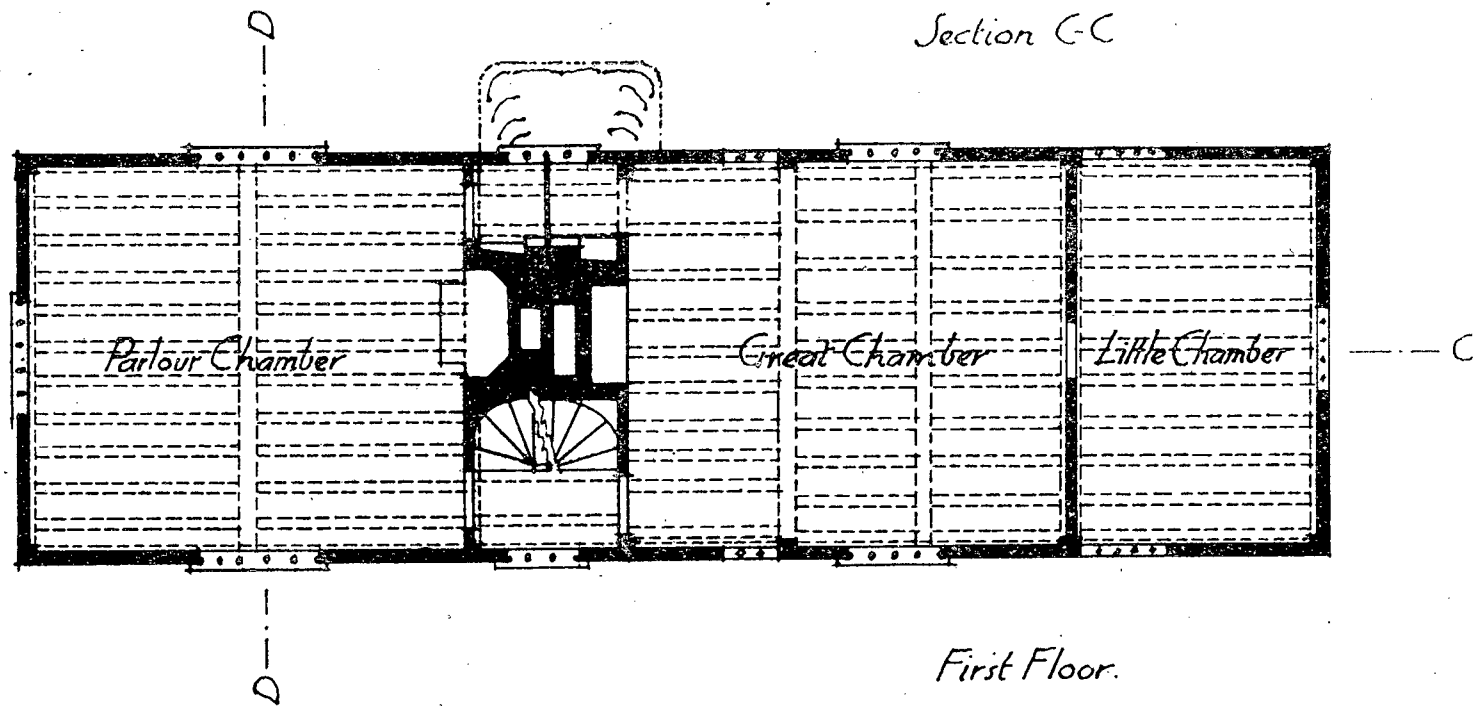
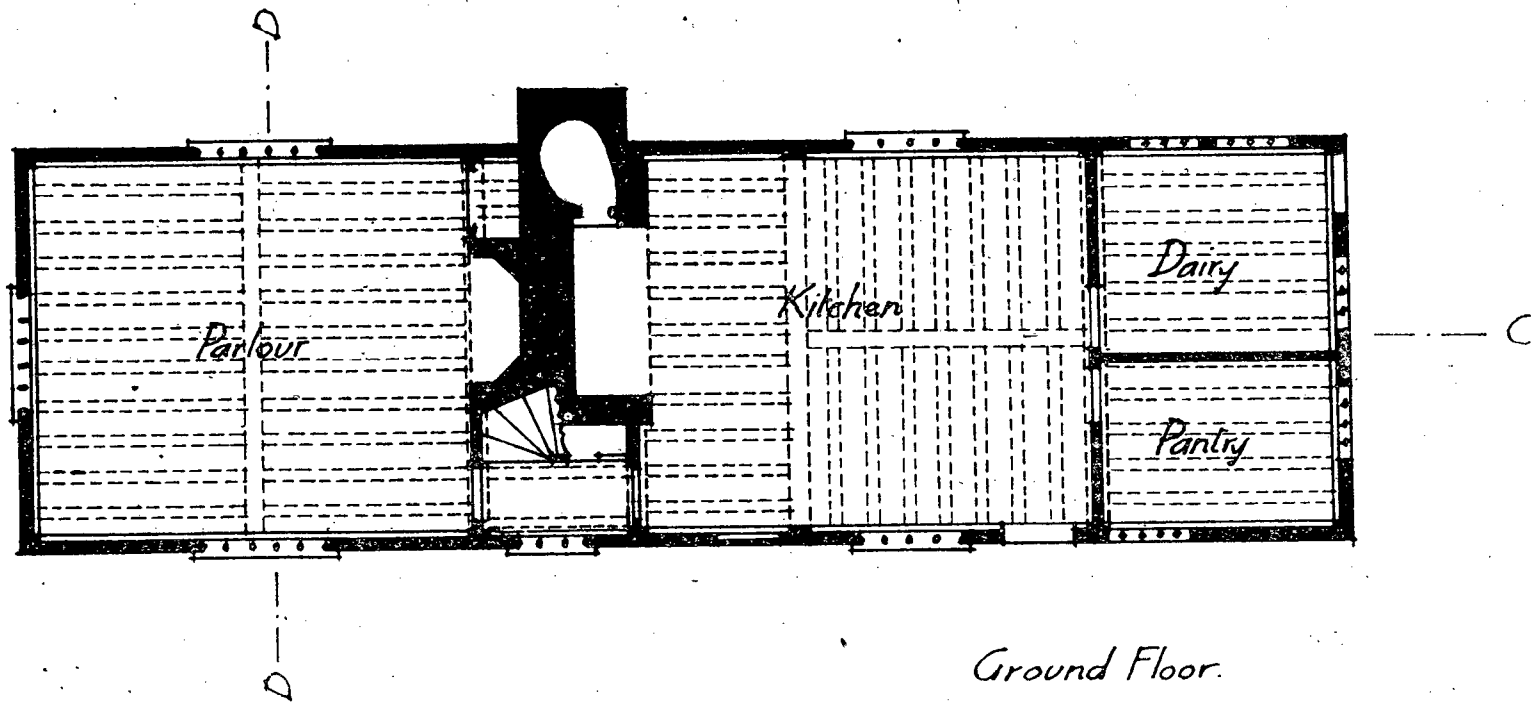
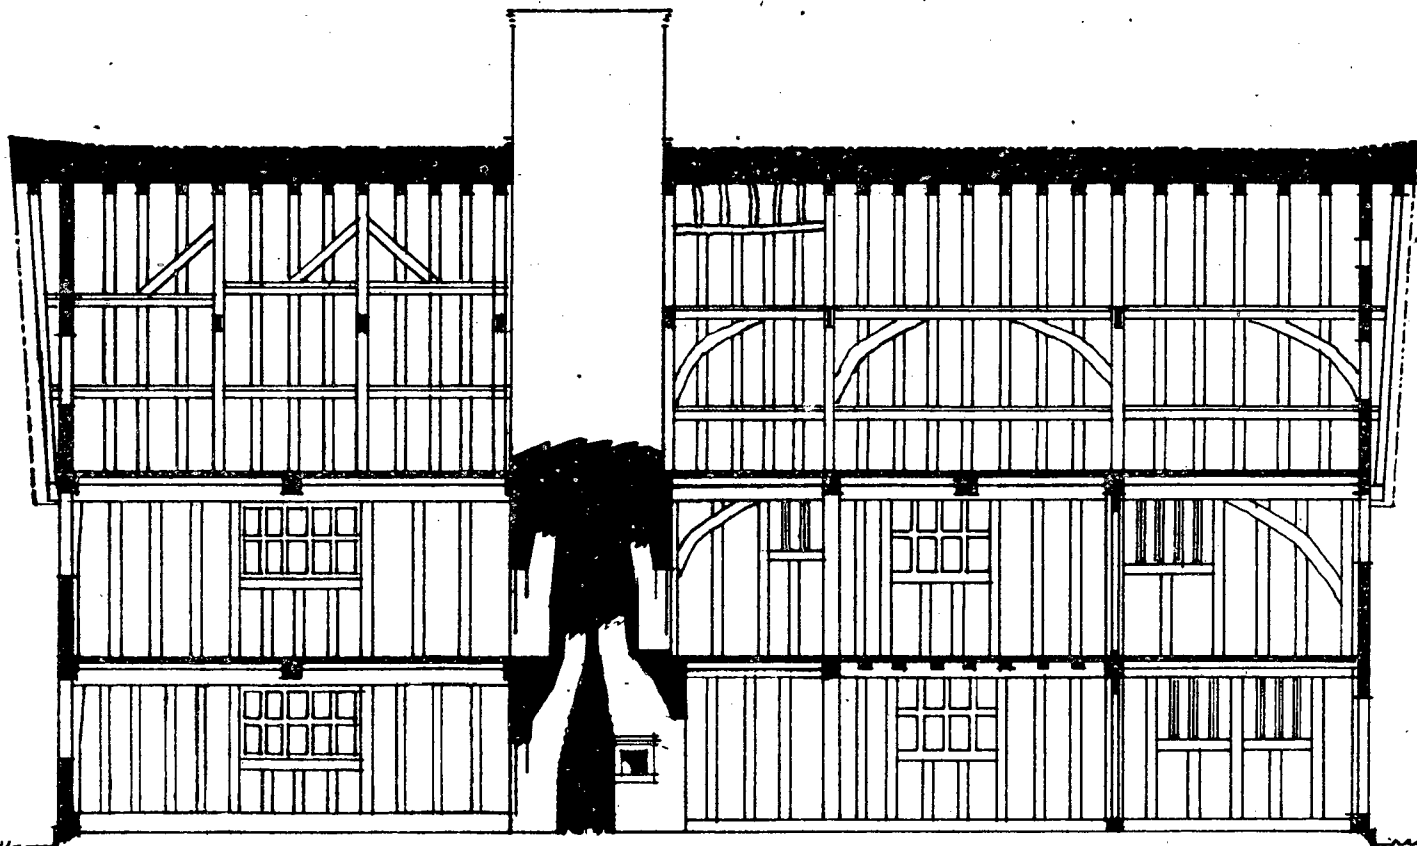
FIG. 3.

Fireplaces. In the Kitchen was a poor cast iron grate of the late XIX century. This was taken out and the old hearth reopened; the bread-oven opening was found to be intact but the oven itself was fallen in beyond repair; it is shown conjecturally in Fig. 3. In the actual work a door was put in here (Plate III) but this is incorrect restoration.

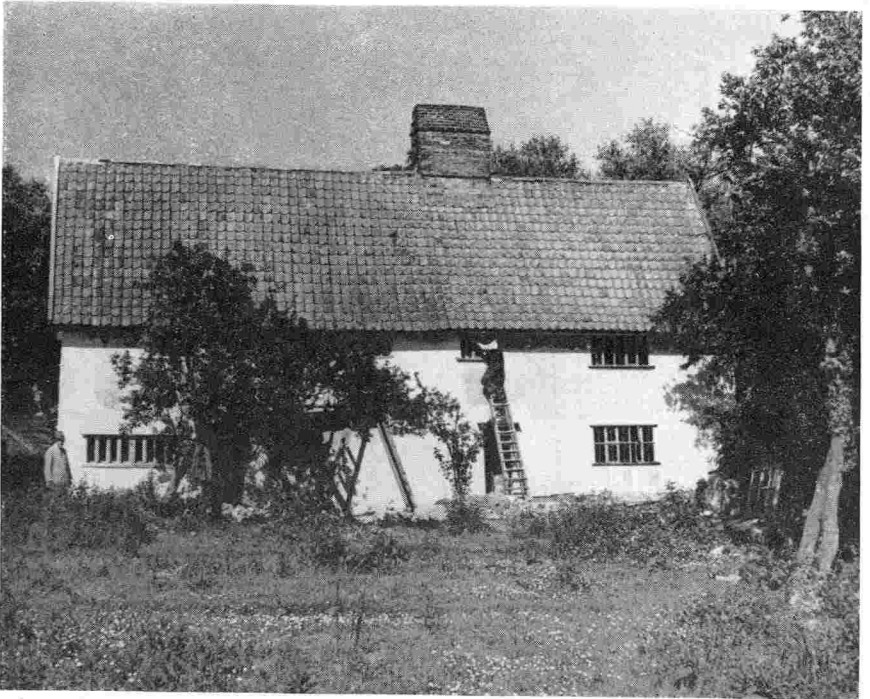
PLATE III.

Fig. 4, shows the house as it appeared about 1580, and this is substantially how it appears after restoration (Plate III). It was not possible to replace thatch in 1940 so the pantiles were retained.

After Restoration.

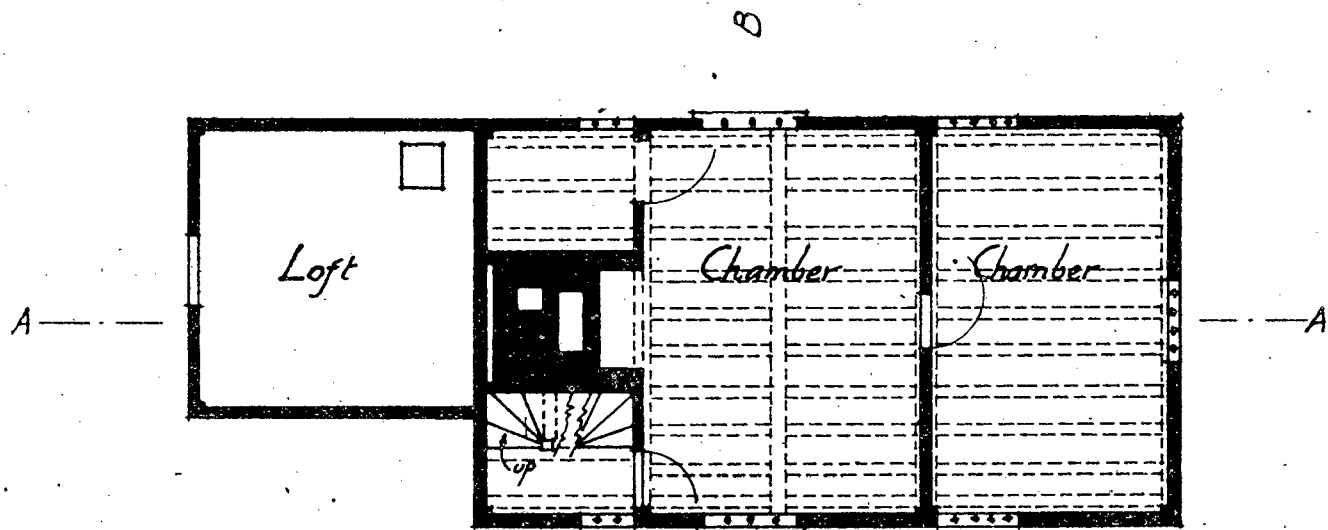
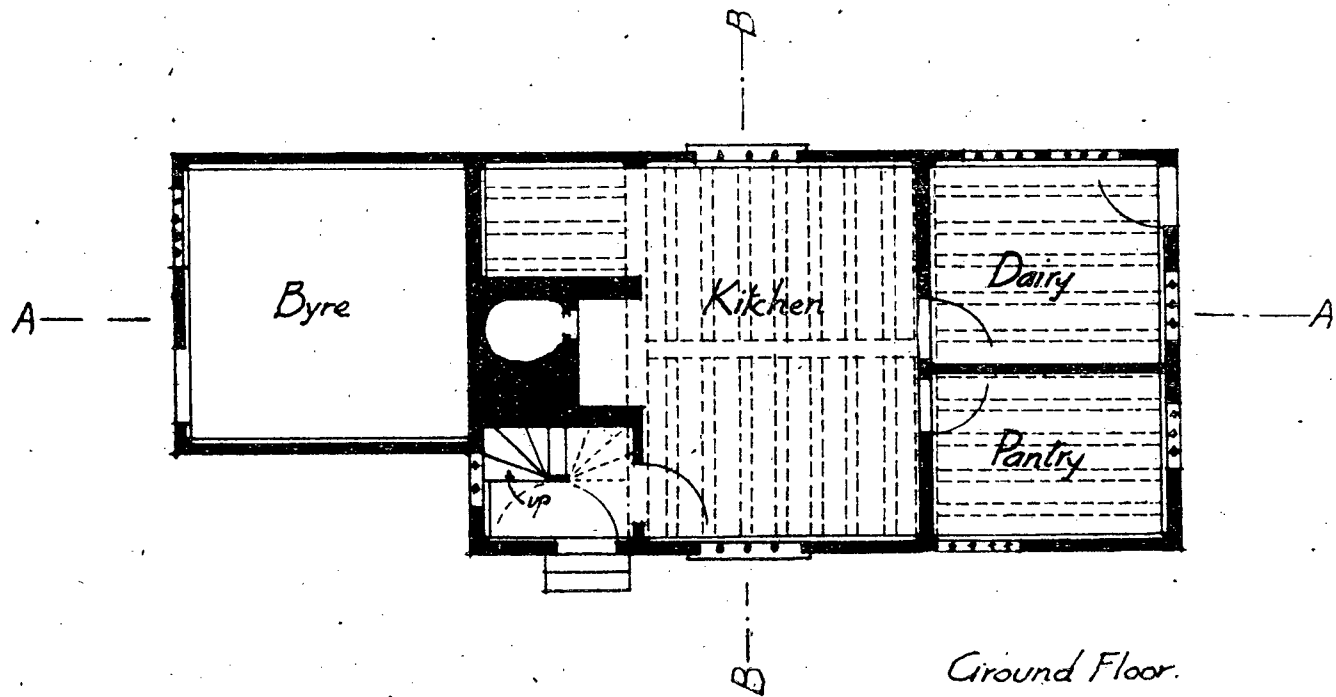
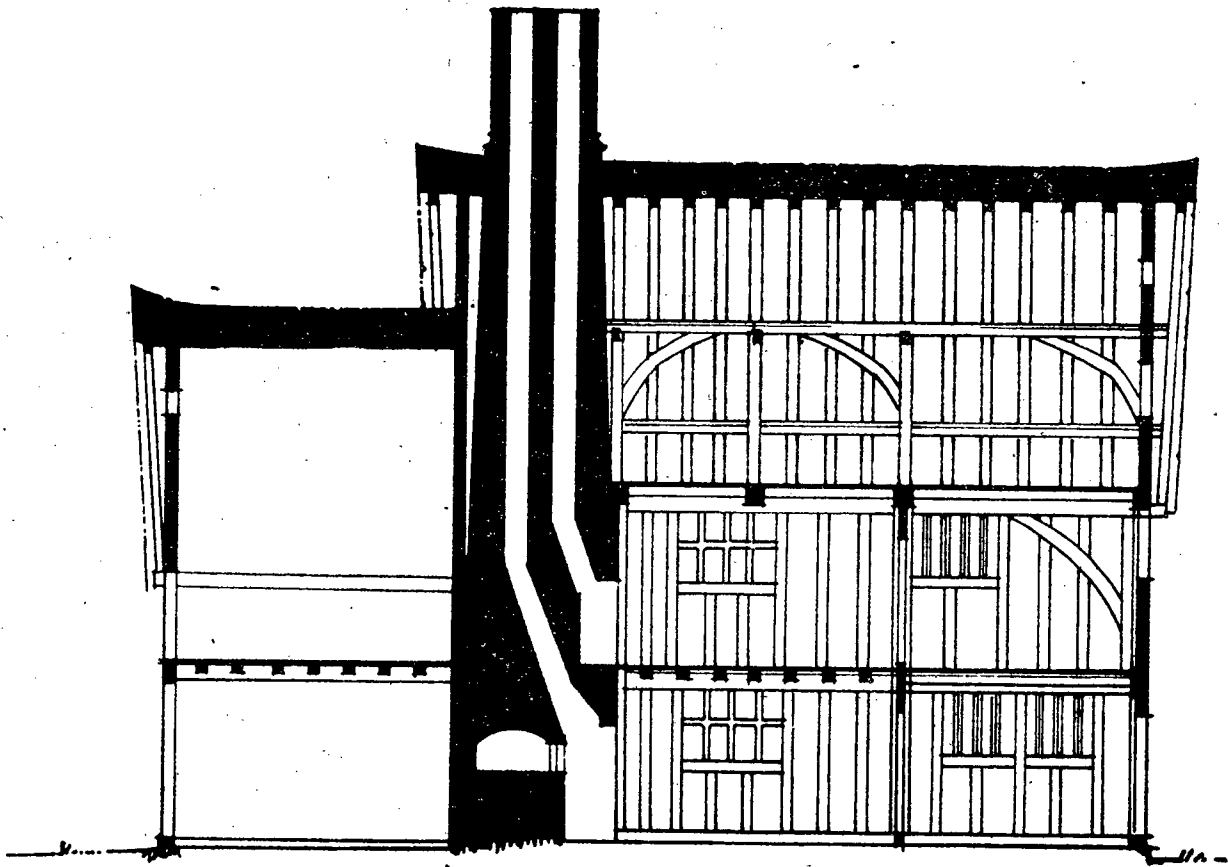
FIG 5.

The chimney stack shown on Fig. 5 does not now exist, but evidence that it did exist is plain. There is a difference in pattern in the brick floor of the Kitchen, almost exactly corresponding with the base of the stack. The short floor joists in the space formerly occupied by the stack and the former staircase are "making good" joists, being of a different section and of inferior workmanship to the rest, and they are of (probably) elm, not oak; similarly the joists over the first floor in the Bedroom. And there is some rather rough making good to the roof timbers where the stack once pierced the roof. Also there are sawn-off tenons of the former partitions on either side of the former stack still remaining in the mortices in the beams.
