Suffolk Institute of Archæology and Natural History.

NOTES ON BURY CORNER POSTS.

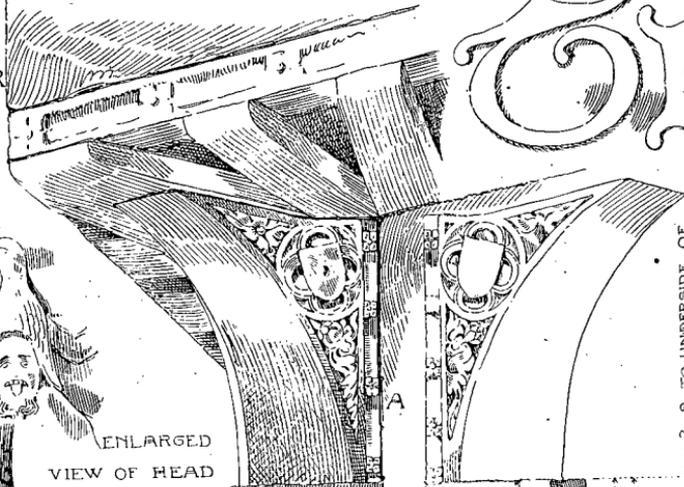
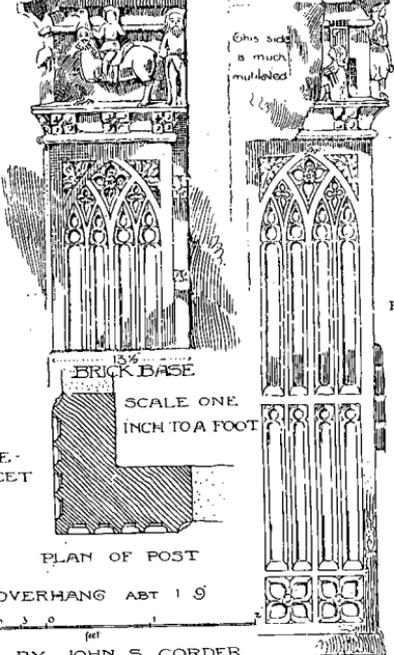
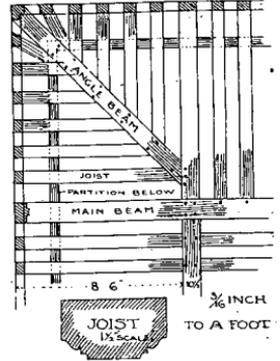
BURY ST EDMUNDS Plate 1 Letters from an Old Beam inside the house

OLD
CORNER
POST

BRICK BASE
SCALE ONE
INCH TO A FOOT

PLAN OF POST

OVERHANG ABT 1 9

PLAN OF JOISTS AND BEAMS

A reference to Plate I will show exactly the part that was played by these posts, and the method of their construction, and how they were framed into the adjacent parts of the building. Briefly recapitulating what I have explained with regard to the

It was framed at the bottom into the cill piece which was laid upon a rubble foundation, and where the cill piece was morticed and tenoned at the angle, the foot of the post was let into these cill pieces, thus preventing the post from shifting at the base. The head of the post was tenoned into the head pieces and pinned into it (see Plate 3), and this plate also shows the large tenon at the top of the post which was framed and pinned into the angle beam, and thus it was impossible to move the post at the head. The angle beam ran out over the bracket of the post and was framed and pinned into the secondary beam of the floor which was in its turn framed into the main floor beam. The floor joists were framed into the secondary beam, and where the angle beam commenced the floor joists were framed into it at right angles to the two external faces. Where the joists next the posts were short and had no wall support, carved pilasters with brackets springing from them were inserted underneath. Thus it will be seen that the construction was a solid mass firmly connected together that nothing could move so long as the tenons and pins held. The doors and windows were all framed in as part of the structure and not as now inserted afterwards.

With regard to the decoration of these posts, let us first take Plate 1 from an example at Bury.

This house, situated in Abbeygate Street, was evidently at one time a structure connected either with the Abbey or some religious foundation, and its internal decorations were elaborate (see Vol. 3, part 2, Suffolk Institute of Archæology, where the building is described by me). The corner post has a bracket with ornamented spandrels, and below the bracket the cap has on one face a fabulous animal symbolical of the lusts of the flesh, with a figure astride of it representing Vanity. Behind the creature stands a man attired in a long flowing robe with a knotted girdle called a discipline round his waist. On the other face is the mutilated figure of a man playing on an organ with pipes.

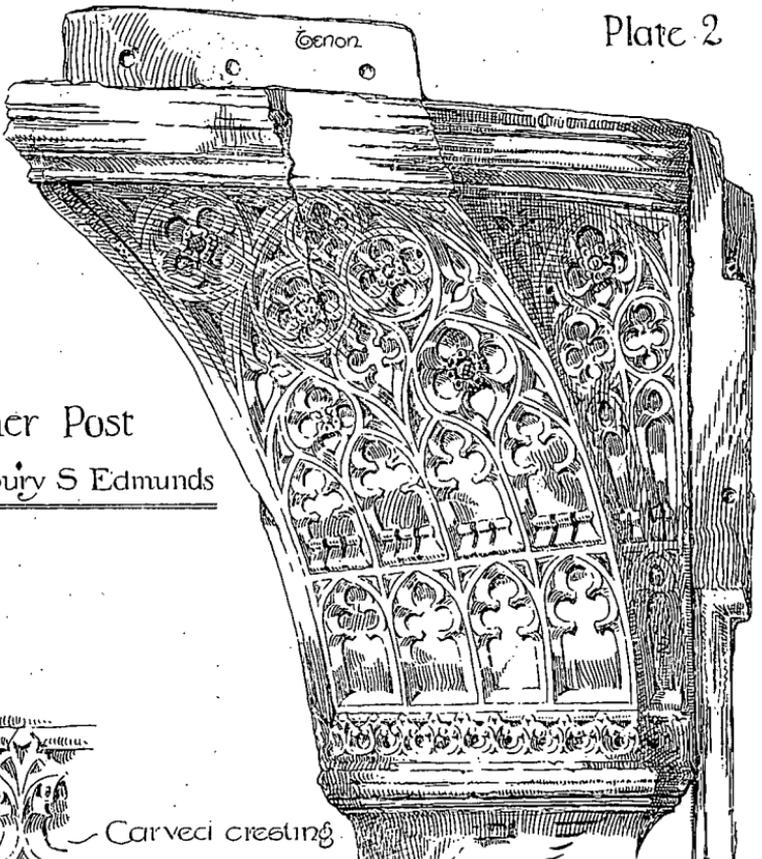
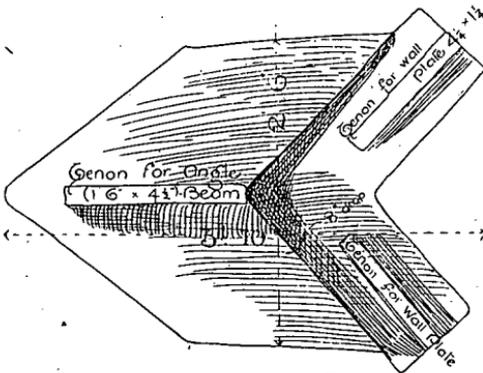
An old
Oak Corner Post
from Bury S Edmunds

Carved cresting

HEIGHT OF CAP 3' 7"
1' 9"

Plan of Top of Cap 1 to a foot

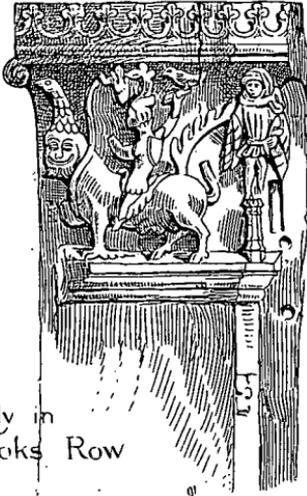
FIG 1

formerly in
Cooks Row

On Plate 3 an exactly similar allegory is represented, but behind the fabulous creature is a man attired as a courtier. This fragment is in the possession of Mr. Hunter, wine merchant, of Abbeygate Street, and came from a house formerly in Cooks Row. Plate 2 shows one of the largest and most

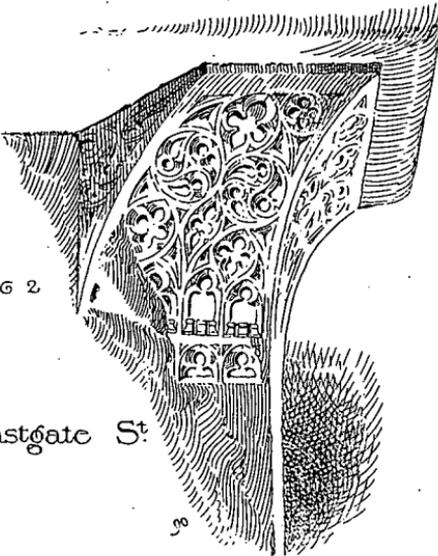
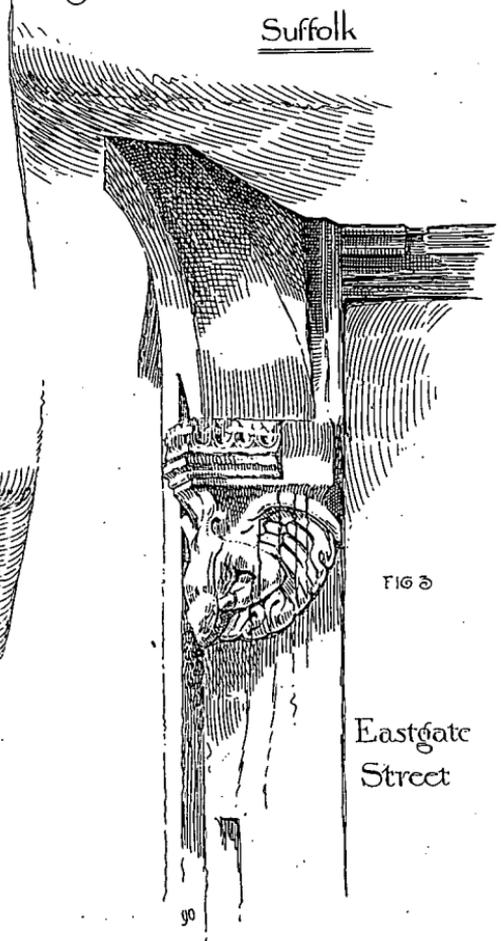
FIG 2

Eastgate St^e

Eastgate
Street

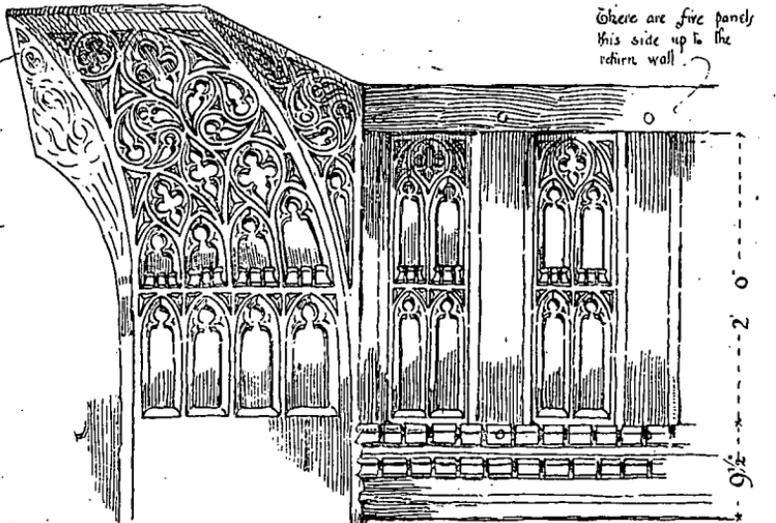
There are five panes
this side up to the
return wall.

The Corner Post
showing paneled
framing at side

Plan of Framing

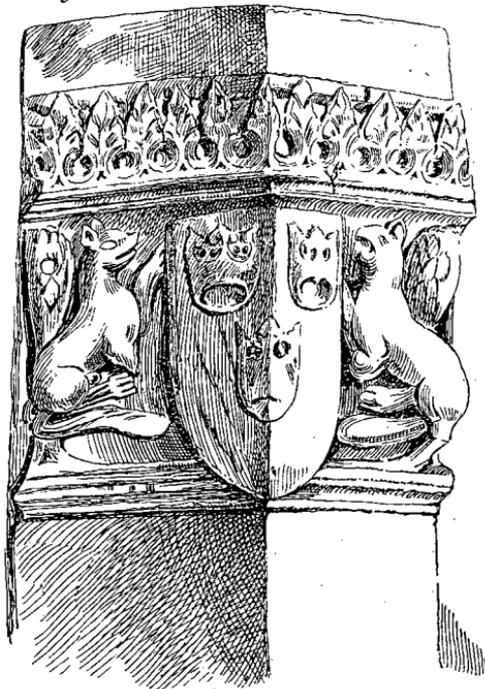
Fig. 1.

Corner Post Moyses Hall

HEIGHT OF CAP $15\frac{1}{2}$ "
 TOTAL WIDTH $18\frac{1}{2}$ "
 SHIELD $10\cdot7$ "
 SIDES $9\frac{1}{2}$ " & 10 "
 OBTUSE ANGLE

In Moyses Hall there is also a fine angle beam end with a carving of the Deity upon it. On the same plate are two figures in canopies from a post now built up in a chemist's shop in Abbeygate Street—early 16th century. The external wall on the ground

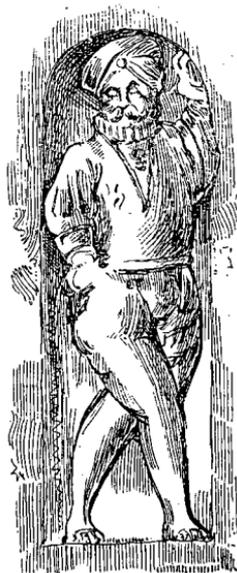
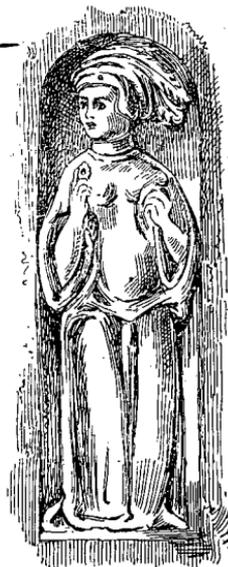
Fig. 2

From Corner Post 56 Abbeygate Plate 5

HEIGHT OF FIGURES $2\cdot0$ "
 WIDTH $6\frac{1}{2}$ inches.

DATE 1514

floor has been built up in line with the overhang so that the post is right inside the shop. The figures appear to represent Henry VIII., and one of his wives and the date of the house is 1514 or thereabouts.

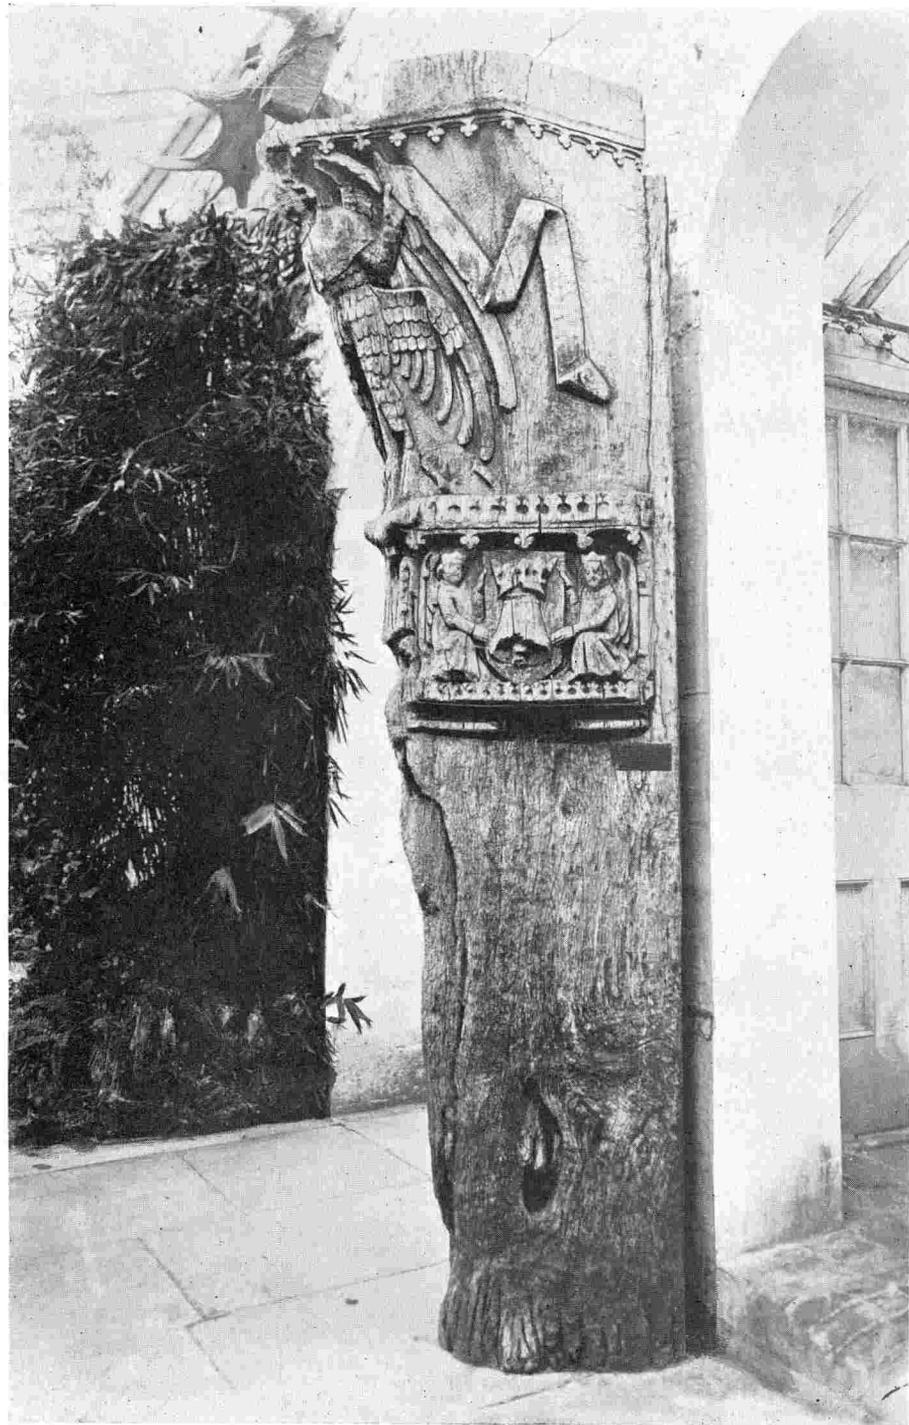
Plate 6.

OLD BELL INN, BURY ST. EDMUNDS.

Plate 6 is from the old Bell in Guildhall Street, and is in the possession of G. Milner Gibson Cullum, Esq., of Hardwick House. It is a beautiful example of 15th century or even earlier. On the bracket is an angel with outspread wings bearing a scroll, and below on one face are two crowned winged figures supporting a shield with a bell surmounted by a crown.

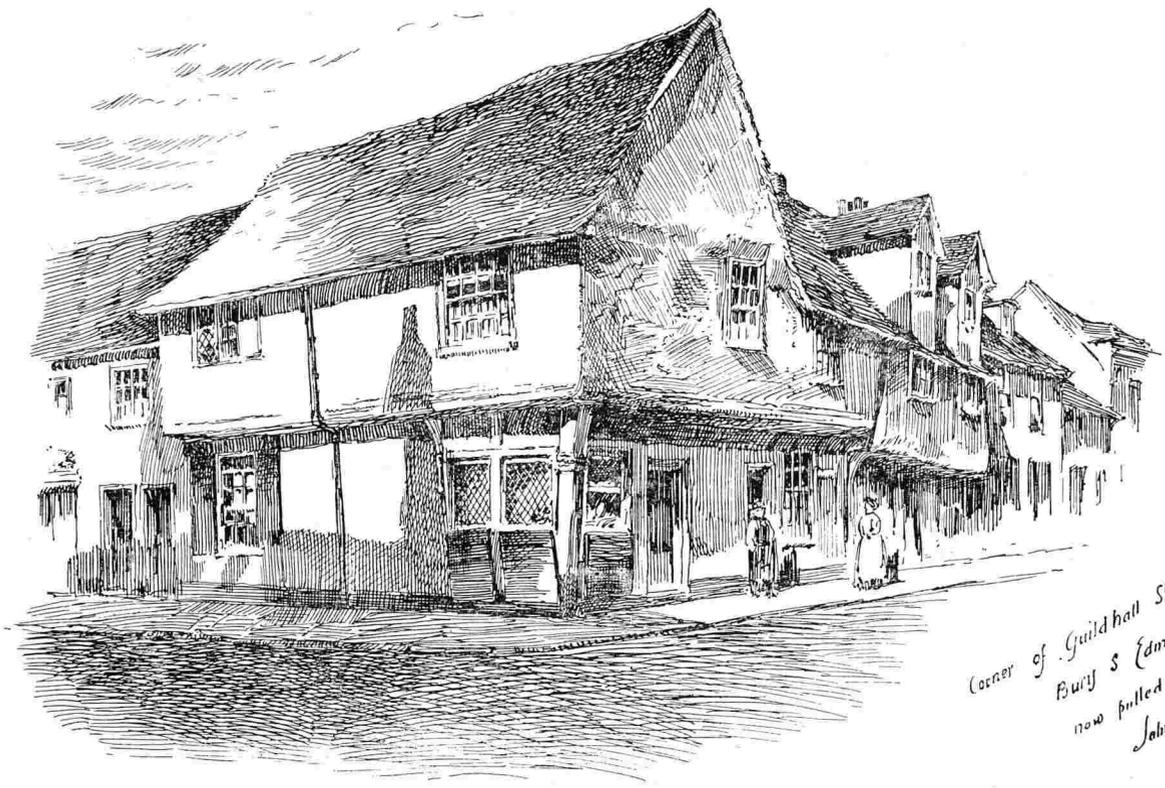
Corner of Guild hall St
Bury & Cammels
now pulled down
John S. Carter

Plate 7 shows an old post *in situ* attached to a house, since pulled down, in Guildhall Street. It is a very early post of simple design, but the buildings are very picturesque in grouping.

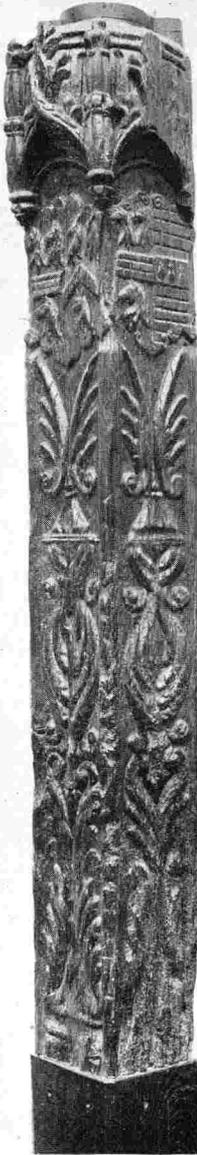
Fig 1

Two Corner
Posts
from a House
Bury S Edmunds
now demolished

Plate 8 shows two posts from a house in Bury St. Edmunds, now demolished, late Henry VIII period. They are now in the Victoria and Albert Museum.

Fig. 1 bears the arms first of Catherine Cotton, wife of Thomas Heigham Cambs, who died 1492, and second Elizabeth Calthorp, who died 1540, first wife of Thomas Heigham, of Bury St. Edmunds. Fig. 2 shews first the arms of Thomas Heigham, of Bury St. Edmunds, combined with his two wives, Calthorp and Poley, and second those of Thomas Heigham alone.
