A UNIQUE WHEEL OF FORTUNE IN SUFFOLK: THE DISCOVERY AND CONSERVATION OF THE WALL PAINTINGS AT THE PARISH CHURCH OF ILKETSHALL ST ANDREW

by TOBIT CURTEIS

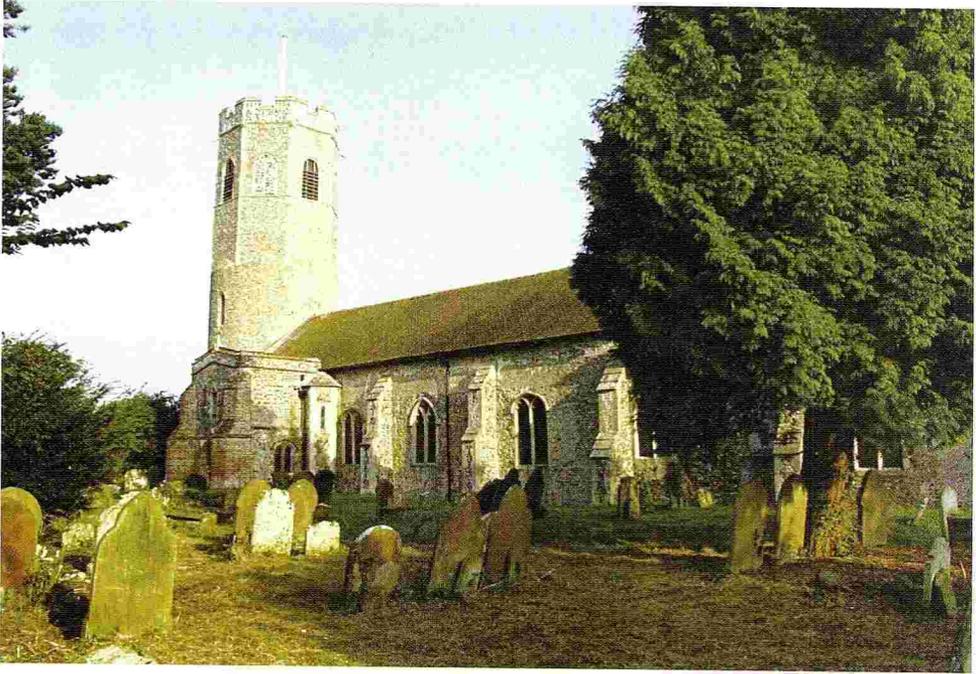
FIG. 119 – External view of the south side of the church (Photo TCA 2005).

Situated in an isolated position on farmland to the north of the widely dispersed village, St Andrew's Church is a long two cell structure, each being of almost equal width, with a round tower at the west end. On the south side is a two storey porch. (*Figs. 119 & 121*) The nave, chancel and tower walls are of flint rubble with brick inclusions, with quoins and dressings of flint and limestone. The roof of the nave and chancel are of modern plain tiles while the porch and tower roofs are covered with lead. Originally the external walls would have been rendered with lime plaster, but this has been largely lost in most areas. Internally all of the walls are rendered. The nave floor is constructed mainly of brick, with memorial slabs in the centre and raised wooden platforms for the pews. The chancel floor is covered with memorial slabs and 19th century tiles.

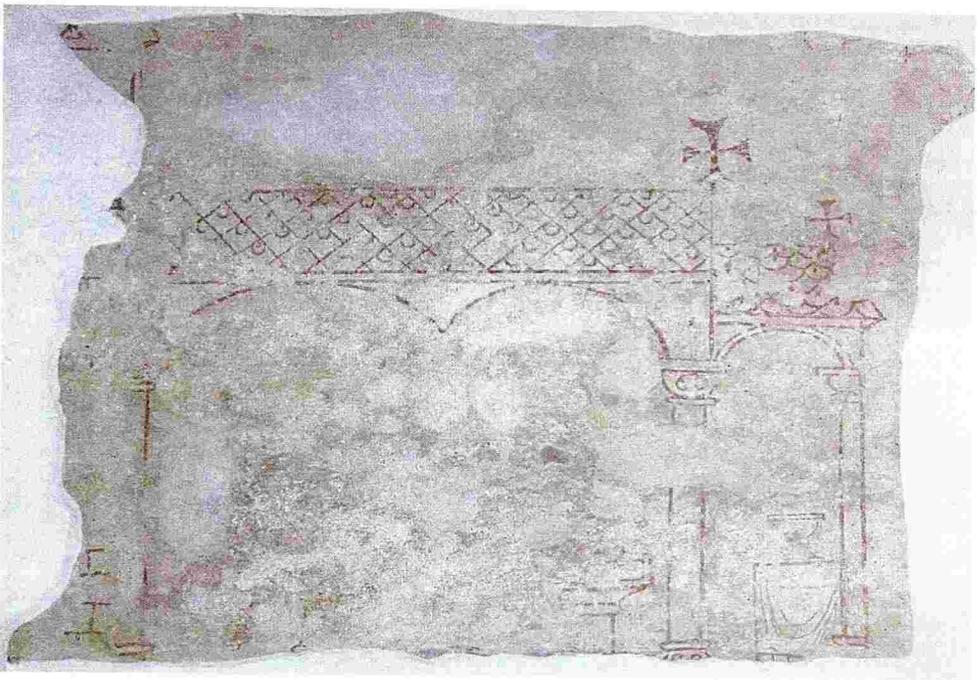
The painting on the north wall shows a large church or cathedral structure, comprising a double arched nave with Romanesque cushion capitals and a smaller single arched chancel. (*Fig. 120*) The capital at the east end of the nave appears to be decorated with an unusual cross or a trefoil. The roofs above are ornately painted with pegged and fish scale tiles and there is a large cross at the end of both the nave and chancel roof. In the chancel is an altar with an altar cloth, on which sits a chalice and paten. At the east end of the nave is what appears to be a large font, while to the west are tiny fragments of painting indicating where further details have been lost. At the west end of the building, there are fragments of a large west tower, with masonry pattern and a pointed tiled roof. On an area below the main painting, small fragments of two horizontal lines were discovered, which mirror two similar lines on the south wall. It appears that this marked a line of separation between the main band of figurative painting and a band dado decoration.

The painting is very simply executed in a linear style with red ochre paint and may be an underdrawing for a more detailed paint layer, which has since been lost. It is also possible that it is the sinopia, or preparatory drawing, for a fresco which would have been applied on a fine layer of plaster above⁴.

FIG. 120 – The painting of the church after conservation (Photo TCA 2005).

The 12th century painting is executed on a single layer of relatively coarse lime and sand plaster, applied directly over the rubble structure of the wall. The paint layer itself is red ochre applied directly onto the plaster. No ground was observed, implying that what survives might have been an underdrawing rather than a finished painting.

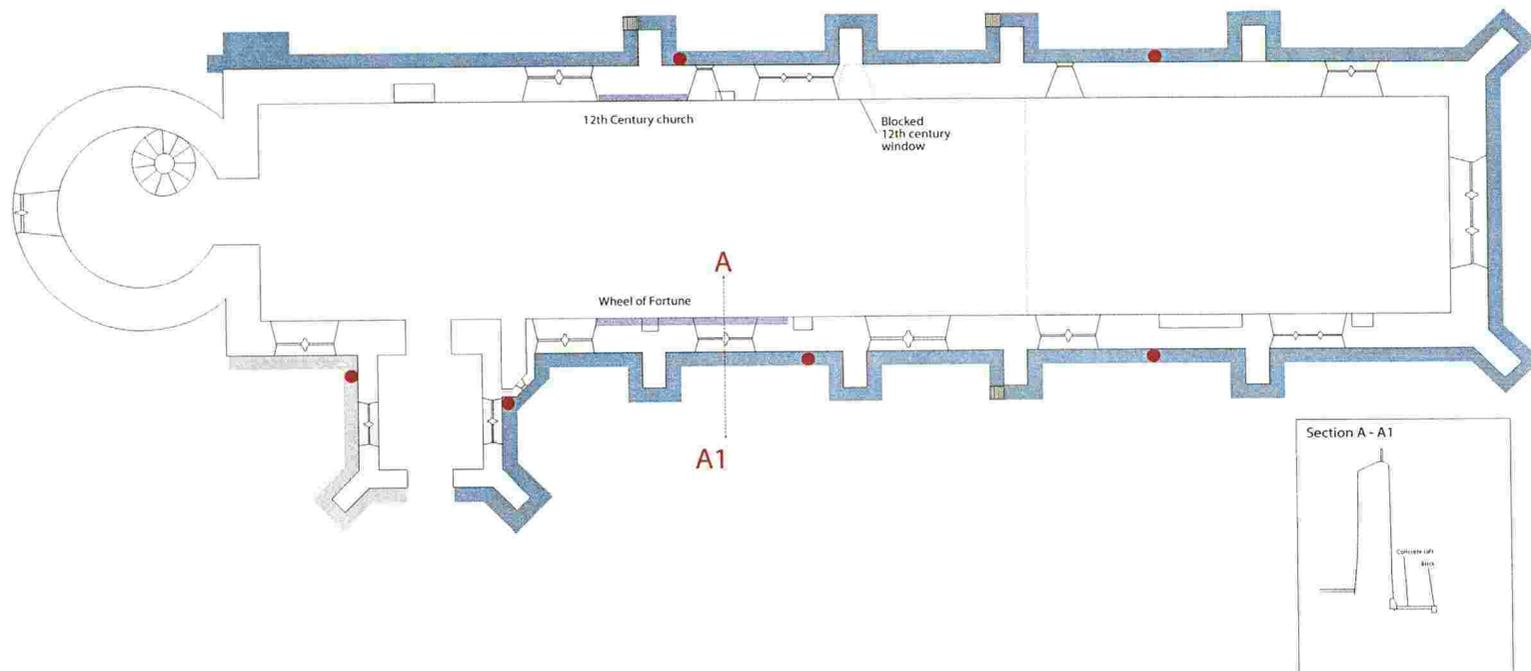
Site: Ilkethshall St Andrew	Type: Location diagram	0m 1m 2m 3m 4m 5m 	Treated areas of painting	
Area: Plan	Date: February 2002	TOBIT CURTEIS ASSOCIATES 36 Abbey Road Cambridge CB5 8HQ	Downpipe Drains Concrete gully

FIG. 121 – Plan of the Church (Photo TCA 2005).

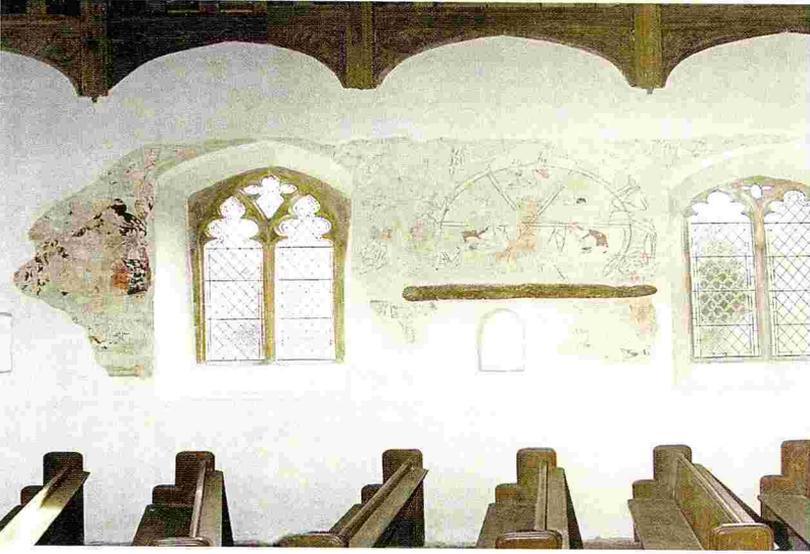
The painting exposed on the south wall spans three main bays, S5, S6 and S7. (*Fig. 122*) The eastern most bay, S7, shows a fragmentary series of large arcades, in which angels with open wings rest on a dark red background) The arcades have ornate tracery, with cusped arches and croquets along their outer edge and possible finials between. The dimensions suggest that there would have been at least three of these major arcades between the two windows, similar in form to a screen or reredos. Within the main arcades are pairs of subsidiary traceried arches, in which are situated standing figures holding scrolls. Only the female figure on the far right has survived intact, while in the two adjacent arches, only fragments of underdrawing can be seen. The female figure in the western arch stands against a red background with ornate white foliate decoration. (*Fig. 123*) She is dressed in a plain red dark robe, with a blue cloak decorated with clusters of three white dots and wears a white wimple and a crown. Her arms are upraised at a sharp angle from the elbows and she holds a white scroll with black lettering. In the spandrel above the western arch is a crowned figure in a red robe, above which are fragments of architectural decoration. (*Fig. 124*)

FIG. 122 – General view of the central part of the north wall after conservation (Photo TCA 2005).

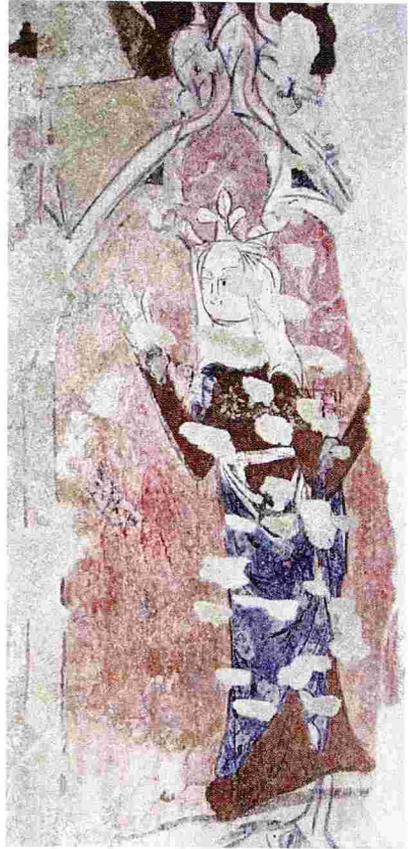
FIG. 123 – The female figure standing against a red scrollwork background (Photo TCA 2005).

The present rather muted appearance of the paintings belies their original appearance. The female figure in the arcade, with a dark red (vermilion and carbon black) dress and a bright blue robe (indigo with chalk) with clusters of white decorative spots (white lead), set against a background of light red (Vermilion with a little red lead) with ornate white foliate scroll work (white lead), gives only a limited insight into how colourful the original painting would have been. The Wheel of Fortune gives even less impression of how bright it would have been, but the analysis shows that the main figures would have been wearing bright red robes (vermilion with particles of red lead), some with clusters of five yellow, almost golden, (orpiment) spots⁶.

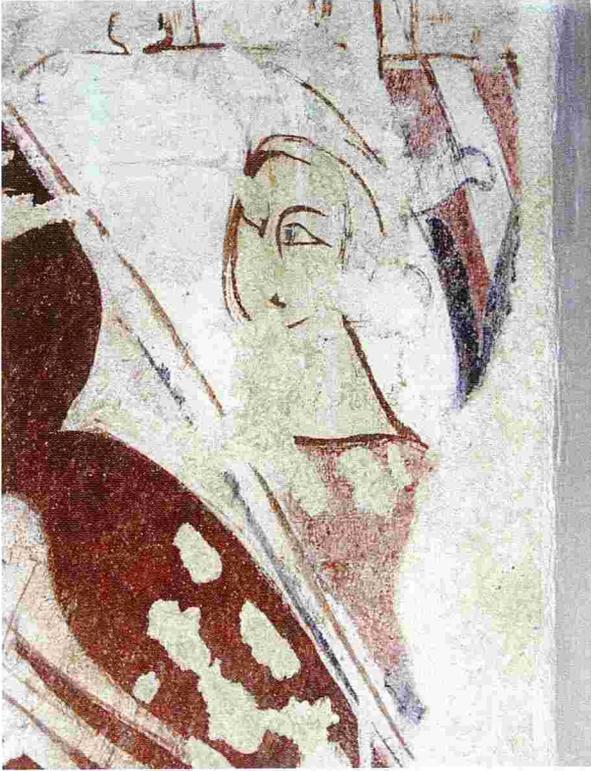
FIG. 124 – Figure of the king and the architectural elements above the arcade. (Photo TCA 2005).

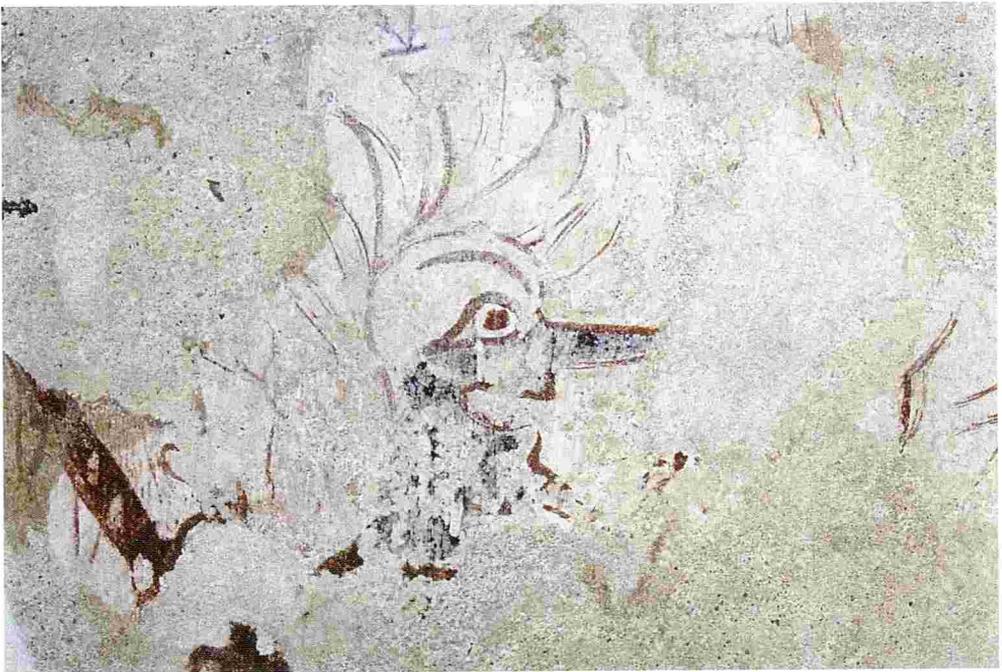
Below the arcade is a band of what appears to be drapery, on which are painted a series of extremely curious demons or monsters. The two most visible are the demon with a cockscomb and spiked nose and chin, (*Fig. 125*) and a fish-like creature with a long beak, which appears to be looking up the dress of the figure. No other example of this type of decoration is known in English wall painting and their significance is unclear, although it is possible that they are similar to marginalia seen in contemporary manuscripts.

FIG. 125 – The two demons below the arcade (Photo TCA 2005).

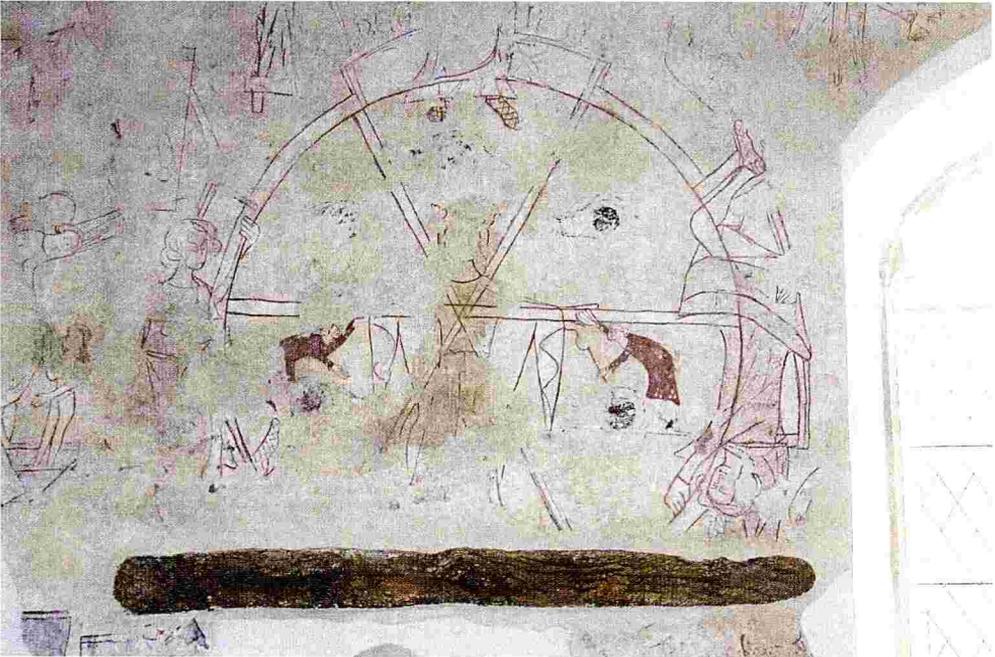
To the right of the window, in bay S5 is a unique depiction of a Wheel of Fortune. (*Fig. 126*) In the centre is a large spoked wheel with the crowned figure of Fortune turning in a clockwise direction, assisted by two small figures. Fortune is difficult to make out as much of the central section is missing, but the crown, and the large hanging sleeves are clearly visible. The small assistants both wear red robes with white dots and one holds a whip. Within each of the segments of the wheel is a large eye, painted in black, which is thought to be the Eye of God.

FIG. 126 – General view of the Wheel of Fortune and the Last Judgement (Photo TCA 2005).

The sketchy red ochre underdrawing is exposed on much of the painting on the south wall as a result of the loss of the main paint layer. Fragments of the flesh paint layer survive on the face of the female figure, but little is present on the figures on the wheel. Similarly, while most of the paint layer on the robes of the figure on the wheel has been lost, the standing female figure has retained almost all of this part of the paint layer. The only preliminary laying out that was observed, was an incised circle around the circumference of the wheel. No similar incisions appeared to have been used for the arcade or the painting on the north wall.

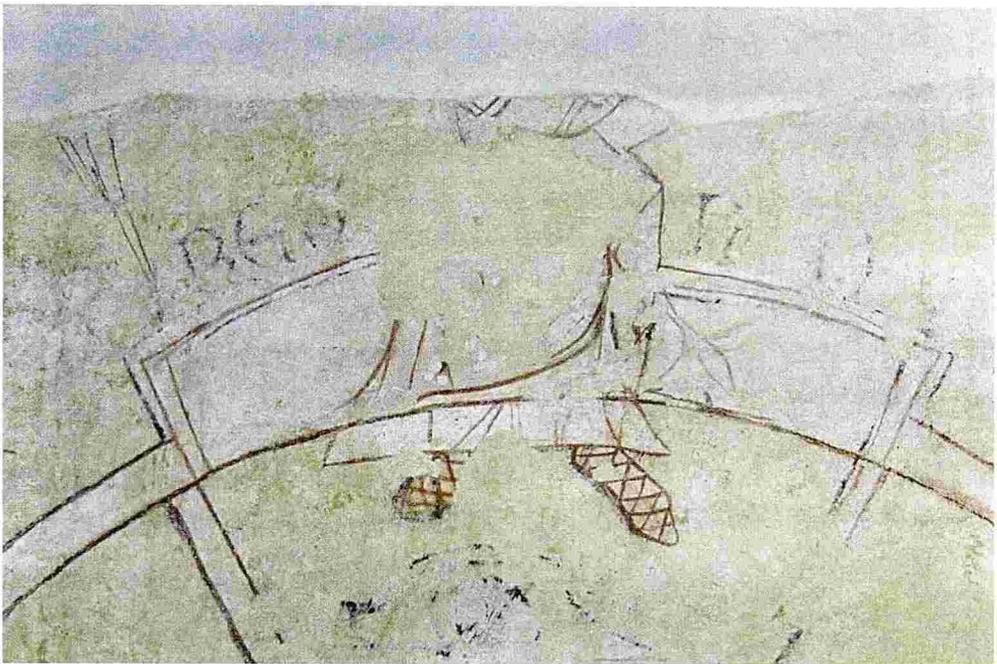
On the left side of the wheel is an uncrowned figure in an ornate robe and carefully groomed hair, being pulled upwards. On top of the wheel is a seated figure with characteristic crossed shoes, flanked by the word REGNO, (I rule). (*Fig. 127*) Although the upper part of the painting is lost, where the wall is cut into by the 15th century alterations, this would originally have shown a crowned king. On the right side of the wheel is a crowned figure, with the same shoes, being cast down. (*Fig. 128*) Although the lower part of the wheel has been destroyed, fragments of one of the hatched shoes are visible, indicating that a fourth figure would have lain beneath the wheel. This distribution of figures being drawn up and thrown down is typical of the iconography of the Wheel of Fortune at this period.

FIG. 127 – The figure in majesty at the top of the wheel (Photo TCA 2005).

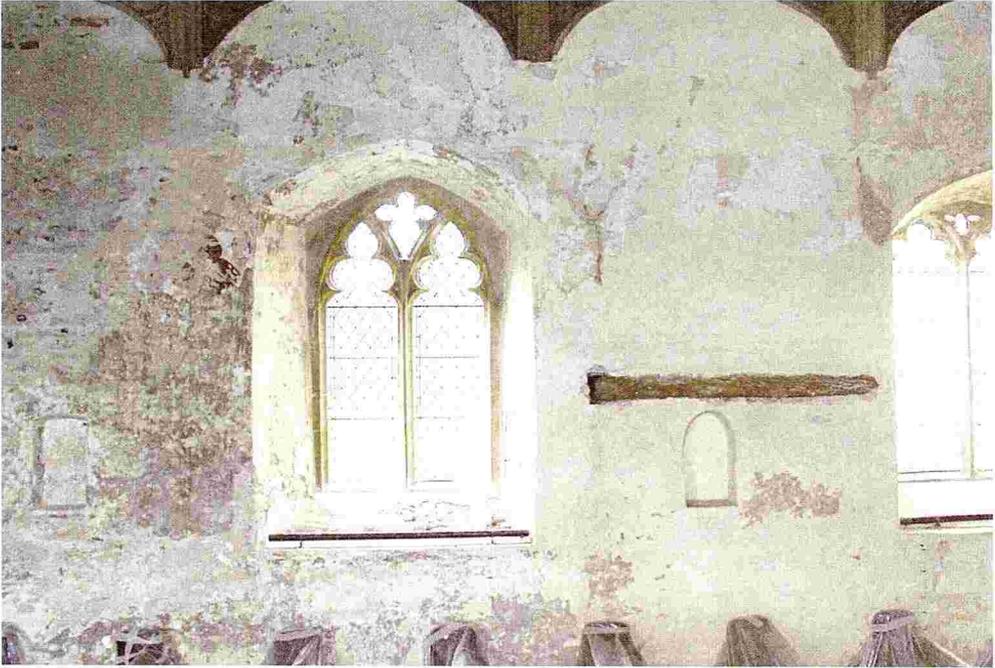
Although there were numerous historic repairs, and significant areas of keying, (*Fig. 134 & 135*) the render on most areas of the north wall was found to be in reasonably sound condition, and despite the recent scraping of the wall, much of the surface was still covered with limewash. The exposed areas of painting were found to have weak pigment cohesion with the original medium typically degraded, however the adhesion to the ground was generally satisfactory. The damage to the south wall was more serious and a significantly larger area of painted plaster had been removed. The most extensively exposed paintings were in bay S7 and these were among the most unstable areas. The cohesion of the paint layer was found to be weak in many areas and some sections were unstable and flaking.

FIG. 134 – General view of the central part of the north wall before conservation (Photo TCA 2005).

Limewash and plaster layers were removed mechanically with scalpels and small brushes and residues were reduced using deionised water on cotton wool swabs. (Figs. 18 & 19) Plaster losses were repaired with 1:4 lime putty and local sand, sometimes toned with ochre pigments. In the limited areas where it was necessary, the readhesion of the paint layers to the limewash ground was carried out using a solution of the acrylic dispersion Plextol B500, following pre-wetting with a mixture of ethanol and deionised water. Where the cohesion had deteriorated to a damaging level, the pigment layer was treated with a solution of the acrylic resin Paraloid B72 in Acetone.

In order to reduce the aesthetic disruption caused by the losses, new repairs were treated using toned limewash and watercolour washes, usually applied with sponges. Minor abrasions were also treated using watercolour washes. No reconstruction of major missing elements of the paintings was undertaken. The areas surrounding the wall paintings were treated with the same toned distemper used throughout the church.

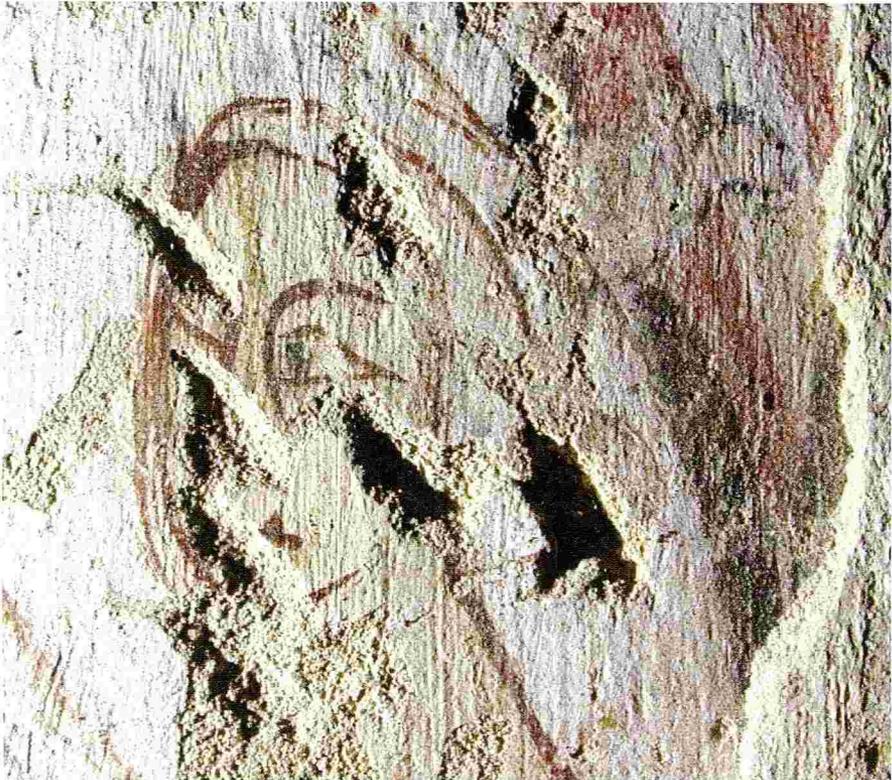
FIG. 135 – Detail of the keying (Photo TCA 2005).

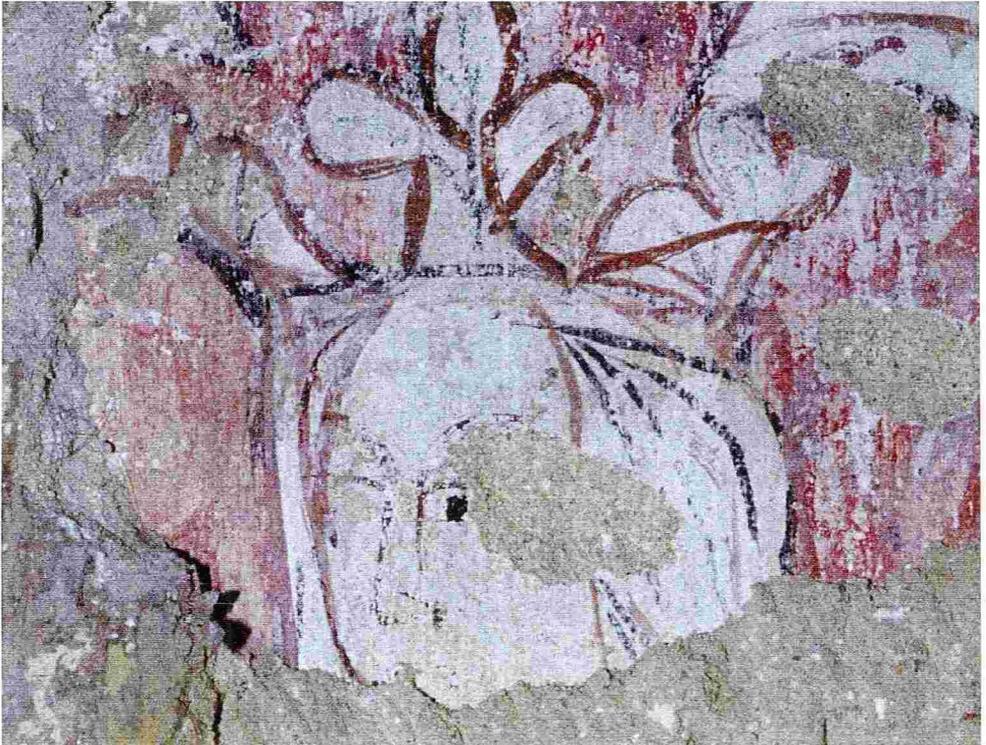
FIG. 137 – The partially uncovered female figure (*Photo TCA 2005*).
