# GIFFORDS HALL, STOKE BY NAYLAND

By DENYS SPITTLE, M.A., F.S.A., A.R.I.B.A.

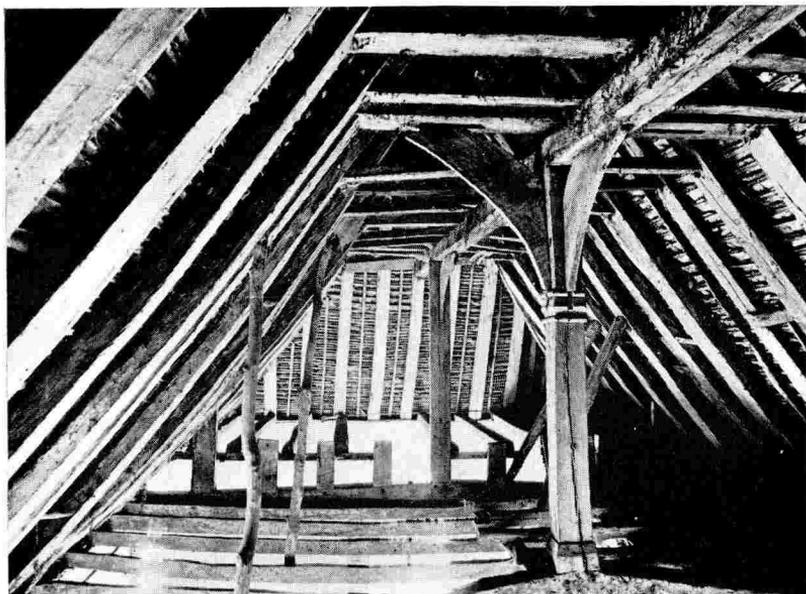
*a.* The roof-structure over the east range looking south, showing the open truss No. 7 and, beyond, the closed truss No. 8.

The open trusses Nos. 4 and 7 on plan (Plate XXVII, *a*) have crown posts with moulded capitals and bases, four-way braces from the crown posts, and cambered tie beams, moulded on the soffits. Sufficient remains of the roof to show that some measure of symmetry was got by providing two equally sized rooms, one on either side of the narrow compartment. Each of these rooms had therefore a central roof truss with an enriched crown post. The truss numbered 2 has been mutilated by a later chimney stack and its form is not clear, but it would be reasonable to assume that it too was an open truss so providing a third two-bay room. The roof system shows that there were small compartments at the northern and southern ends of the range. This building, reflecting that on the west of the courtyard, appears to have been for secondary accommodation, such as lodgings, and was structurally separate from the more important rooms adjacent to the hall.

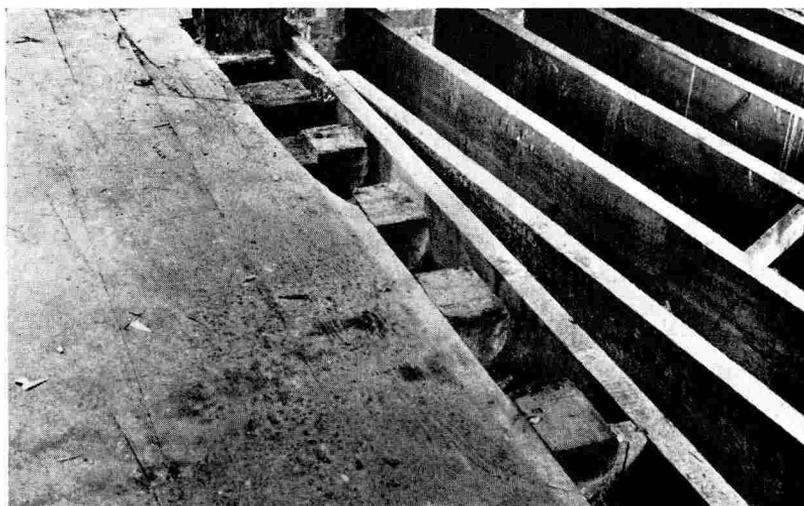
*b.* The ends of joists, at the northern end of the east range, indicating a first floor overhang. These joists were made visible during the repairs of 1934-5 when this photograph was taken, before being again covered over.

*The east range* has been altered by the introduction of sash windows and by changes to the lower storey on the courtyard side; however, the original roof which survives shows that the length and breadth of the range is preserved. During repairs in recent times, floor joists (running E. and W.) with rounded ends were discovered on the western side at the north end, where the range now abuts on the northern range (Plate XXVII, *b*). This undoubtedly indicates an overhang which presumably continued along the whole of this side and returned for a short distance along the southern range (see under 'south range'). This overhang along the east range, having been underbuilt, is not now reflected in any of the present structure. The range must have originally appeared somewhat like that on the west. The roof, which is a particularly good example of its type, has survived largely intact. It is divided into nine unequal bays by roof trusses composed of tie beams, crown posts, collars, and collar

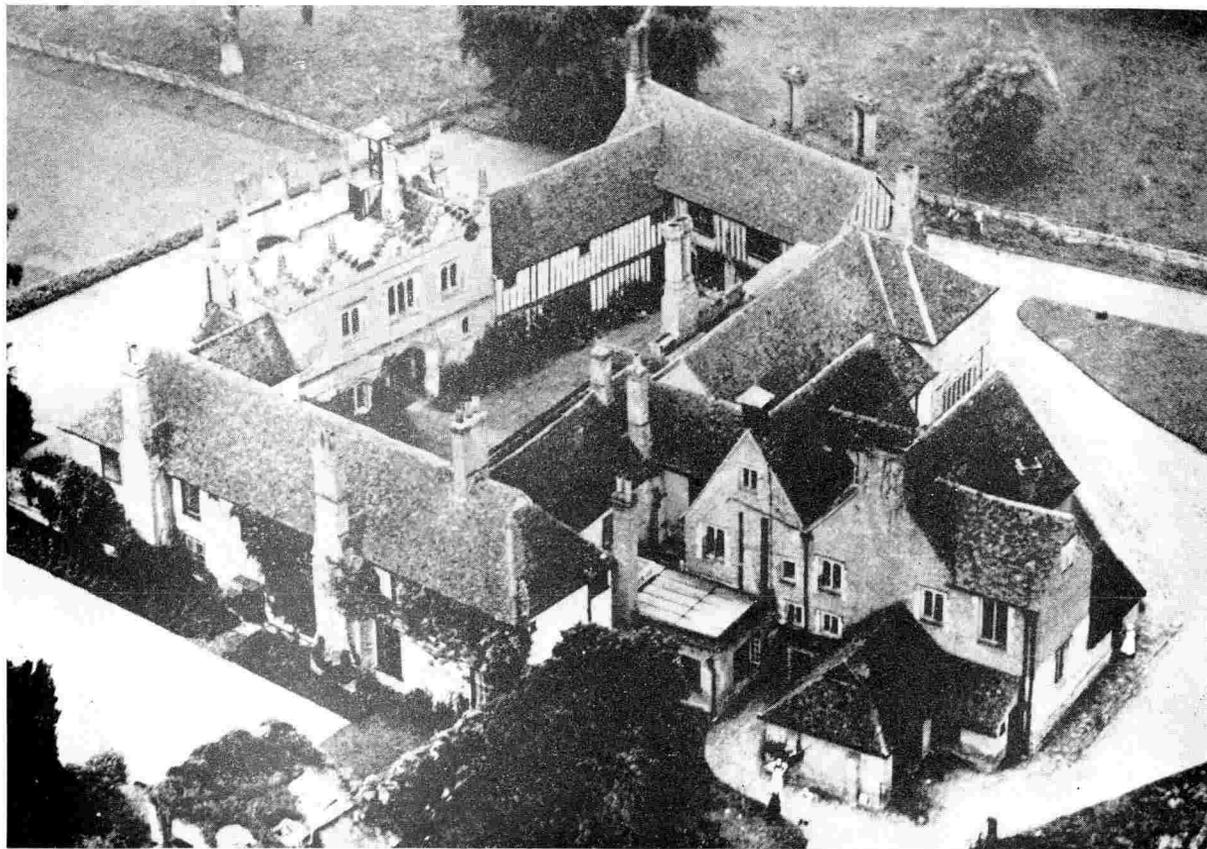
PLATE XXVIII

Giffords Hall from the north-east. An aerial photograph taken before the alterations of 1934-5.

The buildings which stood until 1934 on the north side of the screens passage consisted of two adjacent blocks, the roofs of which were parallel. That immediately north of the hall had a number of storeys, while that beyond it contained the kitchen which seems to have been originally open to the roof, or open at least to tie beam level. There were first-floor rooms over the kitchen at the time of demolition. A bressumer from a kitchen fireplace bearing the date 1642 has been retained, but the two buildings were almost certainly coeval with the main part of the house. The buildings, subsequently encumbered by numerous lesser rooms of indeterminate character, are recorded in a photograph (Plate XXVIII) and in architectural drawings made before their demolition.
