Proceedings of the
SUFFOLK INSTITUTE
of
ARCHAEOLOGY AND HISTORY

THE WEST FAÇADE-COMPLEX AT THE ABBEY CHURCH OF BURY ST EDMUNDS: A DESCRIPTION OF THE EVIDENCE FOR ITS RECONSTRUCTION

by J. PHILIP MCALEER

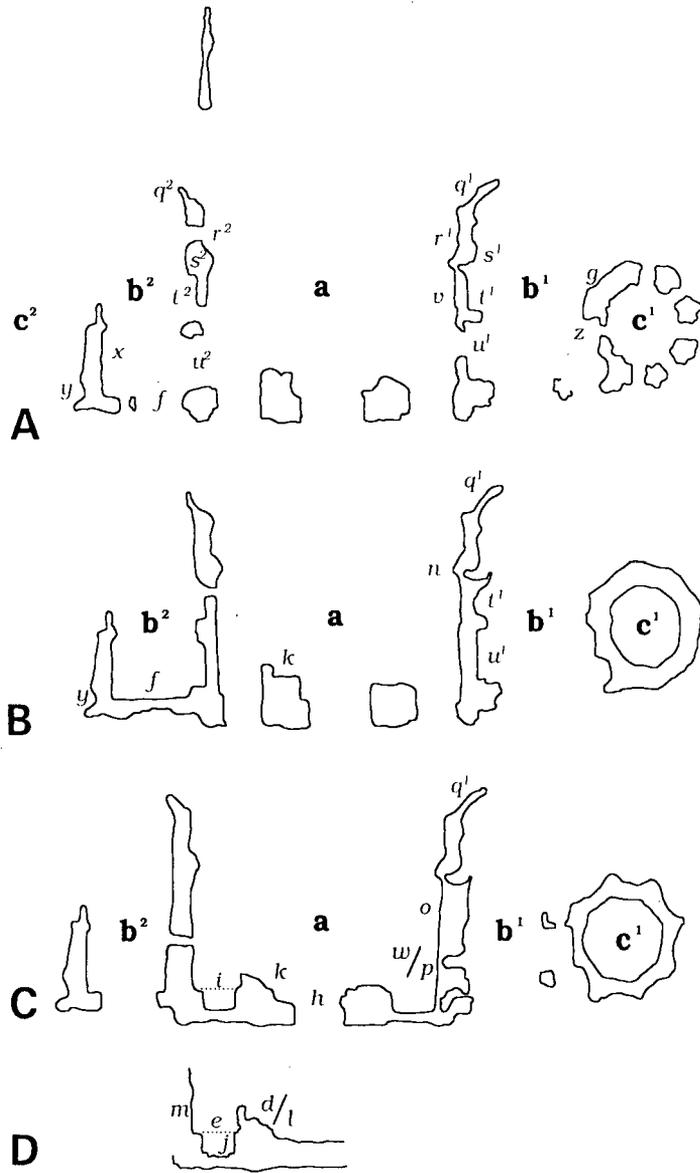
FIG. 24 – Bury St Edmunds, Abbey Church: plans of surviving masonry of western structure (*author, after NBR 86426, RCHME, Crown Copyright, with permission*). (A) at ground level of existing houses; (B) at first floor level of existing houses; (C) at second floor level of existing houses; (D) at attic level of house No. 1. (a) transept; (b) chapel blocks; (c) octagons; (d) stair turret; (e) 15th-century clerestory windows [Fig. 28]; (f) west face of north chapel block; (g) blocked north-east window of south octagon [Fig. 29]; (h) barrel vault of central recess; (i) barrel vault of north recess [Fig. 30]; (j) barrel vault with springers of 15th-century vault below it in attic room of house No.1; (k) north-west respond of west tower [Fig. 31]; (l) fragment of curved walling; (m) 15th-century arch in attic room of house No. 1 [Fig. 32]; (n) springing of gallery arch to transept; (o) blocked arch of south end wall of transept; (p) blocked arch of south end wall of transept; (q) fragment of chapel apse wall; (r) position of window between chapel and transept; (s) blocked newel stair; (t) east arch between chapel and transept; (u) west arch between chapel and transept; (v) 15th-century arch inserted under u [Fig. 36]; (w) west arch between upper south chapel and transept; (x) blocked arch to corridor between north chapel and octagon [Fig. 37]; (y) position of possible newel stair; (z) remains of vaulted corridor between south chapel and octagon.

The structure – or complex, as it is perhaps best to consider it – seems to have consisted of three major elements, two of which were symmetrically repeated. At the core or centre of the complex was a western transept with an axial tower rising over its intersection with the nave (Fig. 24A, *a*). This transept, a nave-like space, and a feature within this period normally found at the east end of the church, as indeed was true of Bury, was (presumably) about as wide and as tall as the nave. However, unlike a normal eastern transept, including the one at Bury, the western transept did not extend beyond the line of the aisle walls. Flanking each end wall of the transept, north and south, were two-storeyed chapel blocks which consisted of a nave and apse (Fig. 24A, *b*¹ and *b*²). And then beyond these was found at each end a large octagonal structure, most probably very like a tall chapter house in appearance (Fig. 24A, *c*¹ and *c*²).³

Flanking the transept at north and south were large chapel blocks (Fig. 24A, *b*¹ & *b*²). They were in two storeys, the resulting four chapels each consisting of an eastern apse and a large rectangular area to the west which formed a kind of nave space. These chapel blocks were almost completely independent, miniature churches in their own right, and quite different from the chapels opening off the transept arms at Ely which were little more than elongated apses. It is difficult to find any contemporary parallels for this arrangement, even on the Continent, let alone in Great Britain. A somewhat similar idea partially survives at the late Ottonian church of Sankt Pantaleon, Cologne (966–1000/05), where it would seem that an originally aisleless nave was flanked at the west end by chapel blocks of two storeys. There were important differences, for Sankt Pantaleon lacked any western transept, the apses of the chapels were contained in the thickness of the blocks' east walls and a large tower rose over the area of the nave between the chapels.⁸ At a somewhat later date, probably before *c.* 1233, certainly by *c.* 1240, large rectangular chapels were built at Lincoln, opening off the western aisle bays of the nave.⁹

Only the west face of the chapel block on the north side remains (Figs 24A and 24B, *f*), that on the south having been completely rebuilt. The wall plane of these two units appears to have been set back from that of the outer arches of the three central giant recesses. Excavations in front of the north chapel in 1958 found the lowest courses of the west wall towards its north end.²⁵ The original lower part of the wall visible above modern ground level is featureless, except for a jagged archway into what is now a courtyard (to No. 1A). This wall has been rebuilt from the level of the neo-Romanesque window above, certainly including the arch over the window. In the room behind (part of house No. 1A), there are the remains of the springing of a rubble arch north of the window, at a level appropriate for an earlier window.

Of the two octagonal structures, only that at the south survives (*c*¹ in Figs 24A, 24B and 24C), preserved in its complete circumference for a height greater than any other part of the façade ruins except for the east wall at the north end. The northern octagon has been so thoroughly demolished that not a trace of it remains (Fig. 24A, *c*²). Because of its denuded state, the only architectural features remaining are the window openings, of which only the blocked north-east window was never subjected to a neo-Romanesque remodelling (Fig. 24A, *g*; Fig. 29).²⁶ Judging from this single unaltered one, the windows were semicircularly arched rather than pointed. As there is no hint of an original cornice or eaves, it is impossible to know if the octagon rose significantly higher than its preserved state. Unlike the other parts of the western complex, excavation on the exterior of the octagon would not produce any significant information for solving problems about its form, although the lower parts of the buried wall may well preserve its ashlar facing and base mouldings, the profile of which might provide evidence for the date of its construction.

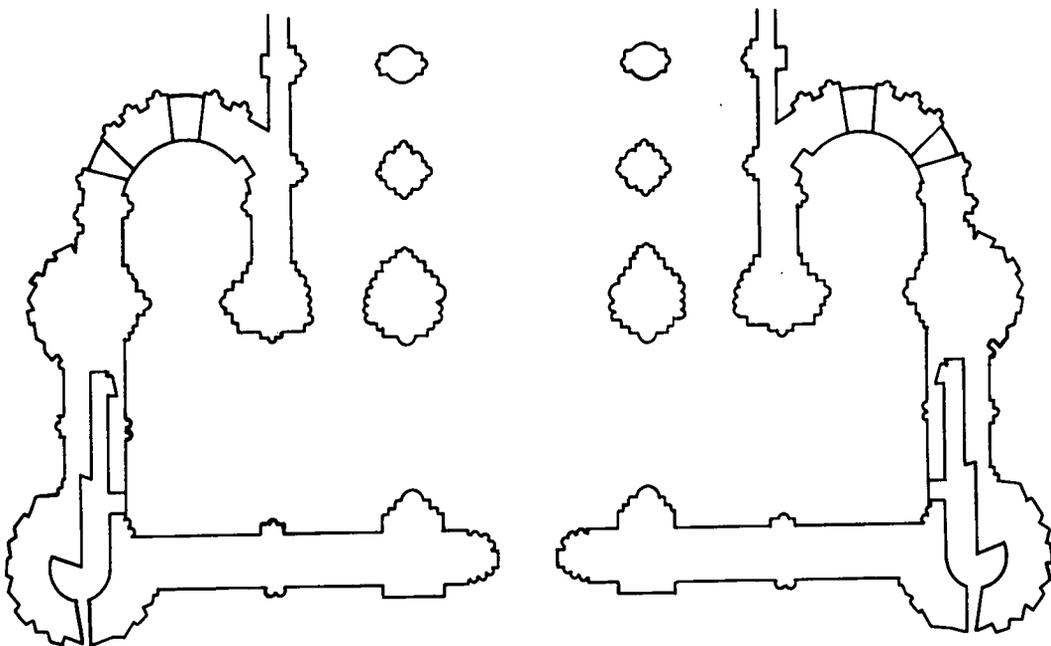
FIG. 25 – Ely Cathedral: author's reconstruction of plan of west transept, after *The Builder*, LXII/2565 (2 April 1892), plan (Roland W. Paul) after 276 (drawing: K.L. Clark).

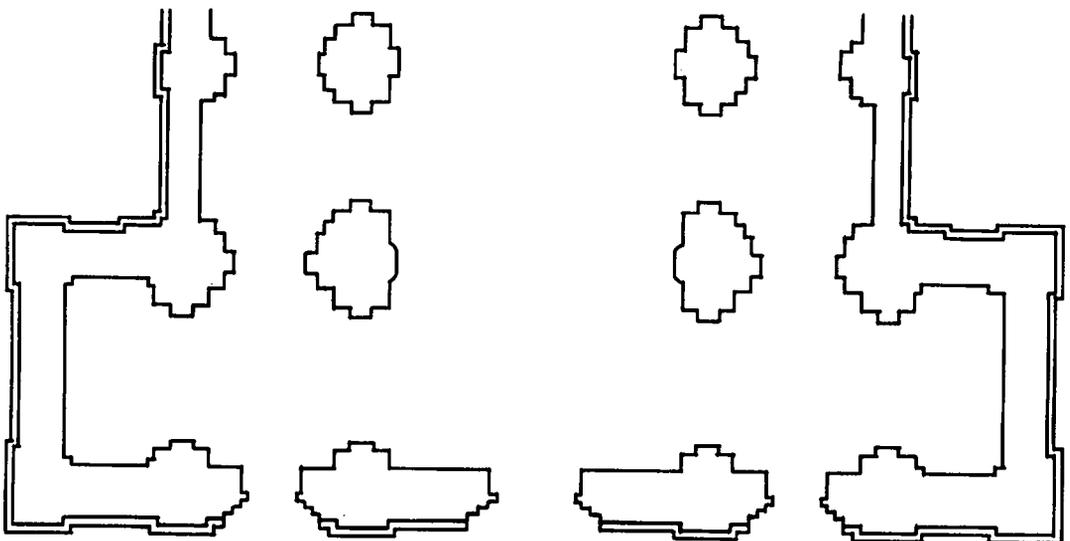
FIG. 26 – Peterborough Cathedral: author's reconstruction of plan of west transept, after *The Builder*, LX/2513 (4 April 1891), plan (Roland W. Paul) after 260 (drawing: K.L. Clark).

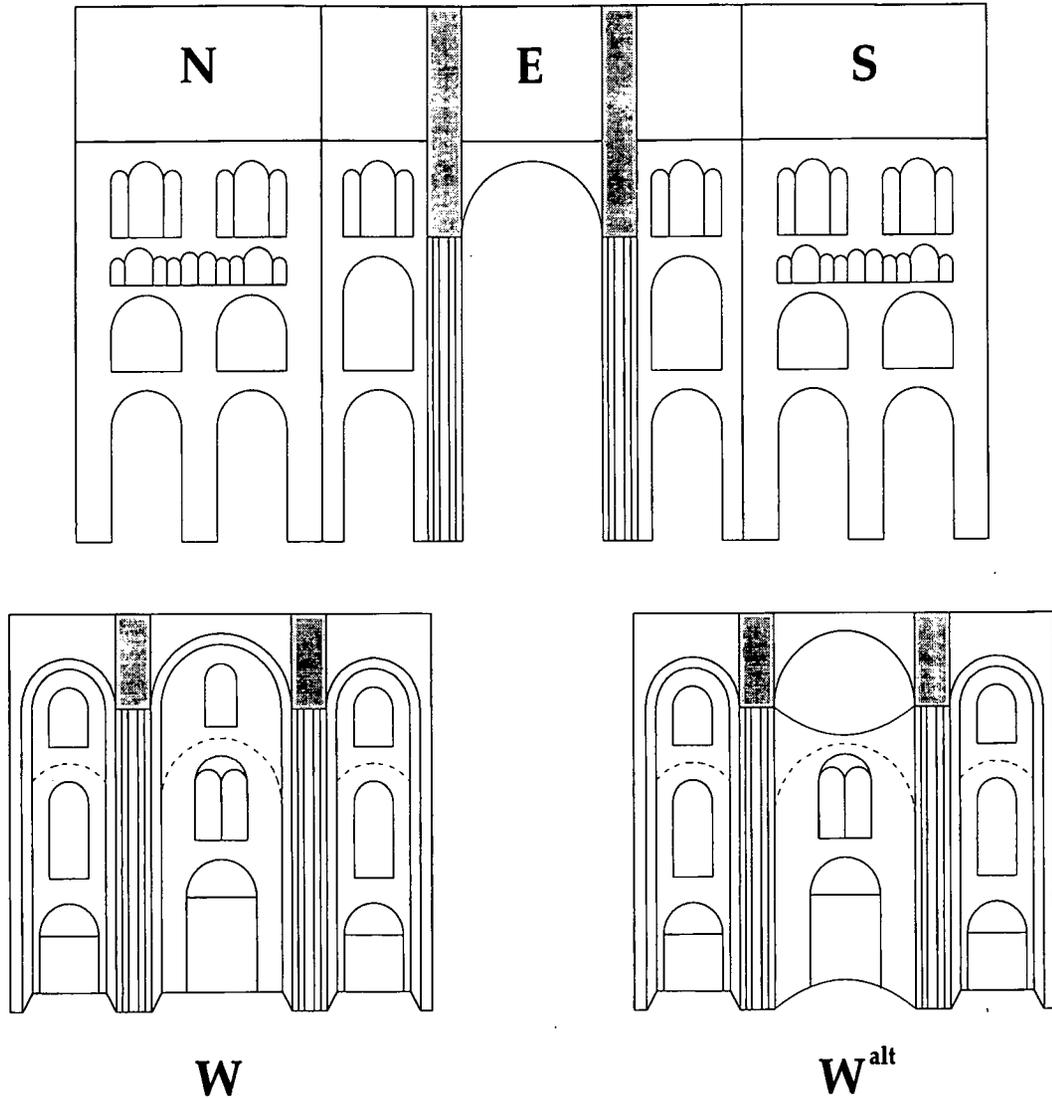
FIG. 27 – Author's diagrammatic reconstruction of internal elevations of west transept
(computer realization: R. Lewis).

The east side of the transept can in any case be reconstructed only on the basis of presumptions, since the crossing piers are not preserved above ground level (Fig. 27). Once again, excavation might produce their remains; until then, we can only surmise that they bore multiple shafts similar to the crossing piers at the east end of the nave. North and south of the piers, there would have been the arches of the aisles and above them the lower ones of the galleries of which the southern springing of the south gallery arch only is preserved. Nothing remains to indicate the nature of the clerestory which was most likely also returned above the gallery arches (as it is at Ely).

The design of the Romanesque end elevations of the transept may now be reconstituted in its general outlines (Fig. 27). At floor level there were two large arches, apparently as tall as those of the aisles; above them there were two much lower arches opening into the upper chapels. These upper chapels and arches, surprisingly, seem to have been lower than the galleries over the nave aisles: at Ely, the arches to the (two) upper chapels which open off the transept space (one in each arm), were as tall as the gallery arches. No evidence survives for the clerestory, but if one with its passageway was maintained at the same level as in the nave, the small arch still evident (adjacent to the springing of the gallery arch) may have formed a series of arches, either blind or open to a lower level wall-passage.

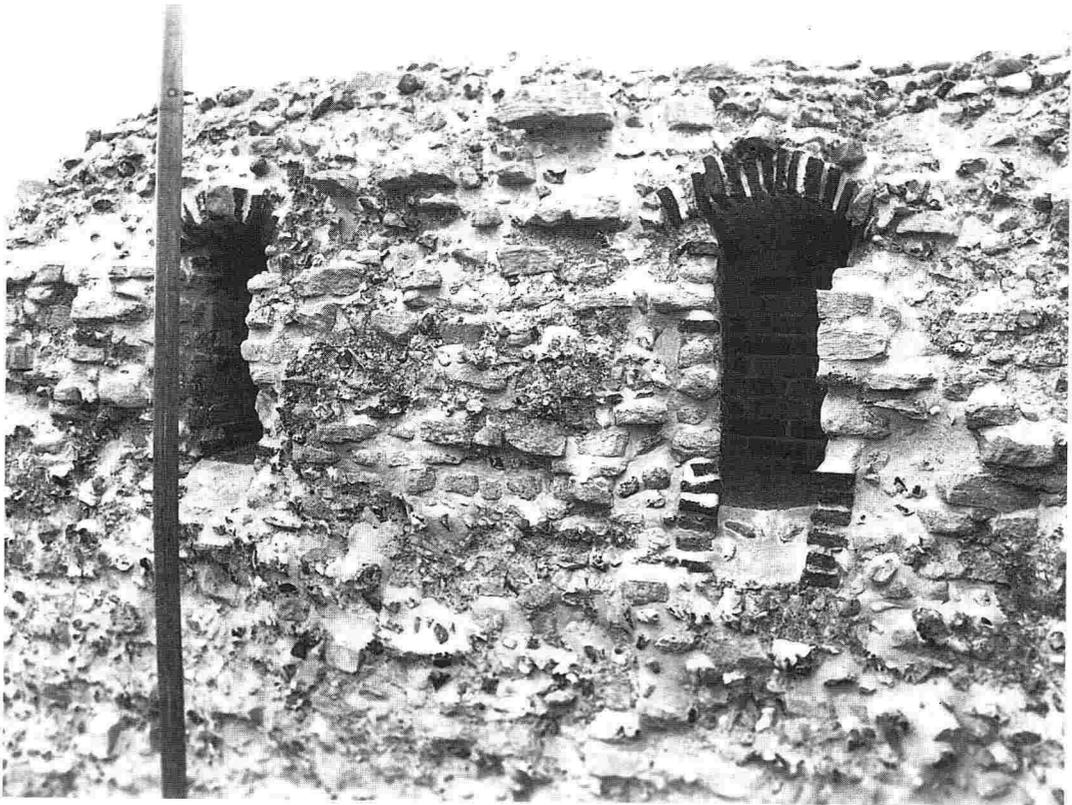
FIG. 28 – Fifteenth-century wall above north façade arch (adjacent to stair turret) with two small clerestory windows [Fig. 24D, e] (photo: author).

Adjacent to the stair turret on the north is an area which is now covered by a modern lean-to roof, recently renewed. An undated photograph taken from the gate tower looking down on the west front shows this area covered by a flat 'cement' roof;²⁴ a deep horizontal line visible at the base of the wall at the east suggests that there was once an earlier lean-to roof over part of this area. The east wall survives to a height equal to the remains of the polygonal turret: two small rectangular openings, with splayed jambs opening towards the east, are its only features (at *e* in Fig. 24D; Fig. 28).

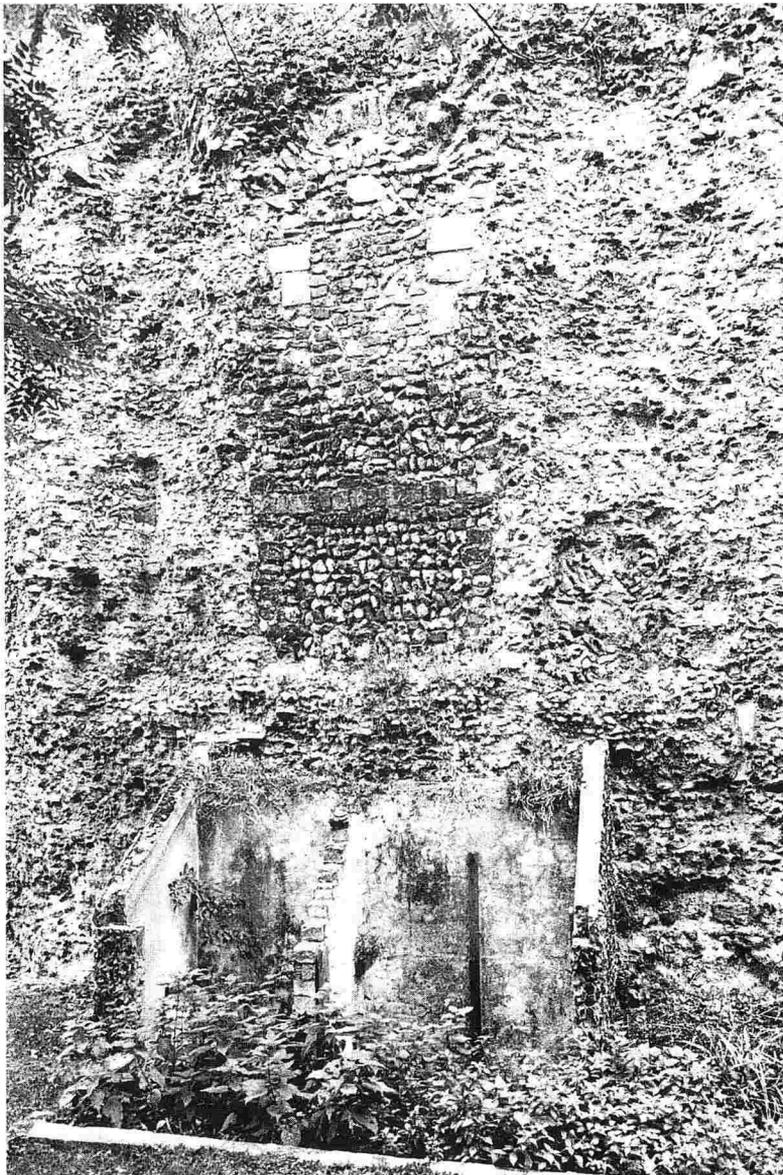
FIG. 29 – South octagon, blocked window on north-east face [Fig. 24A, *g*] (photo: author).

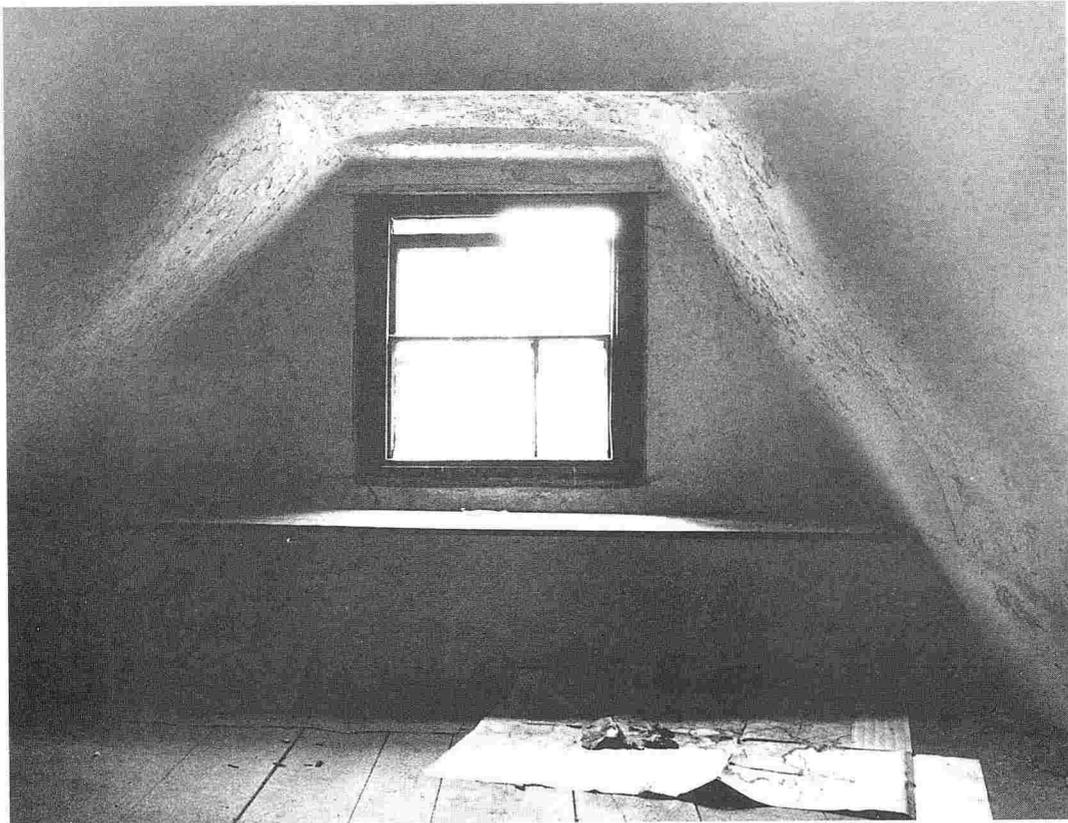
FIG. 30 – Arch of north façade recess from inside upper room in house No. 1 [Fig. 24C, *i*] (photo: author).

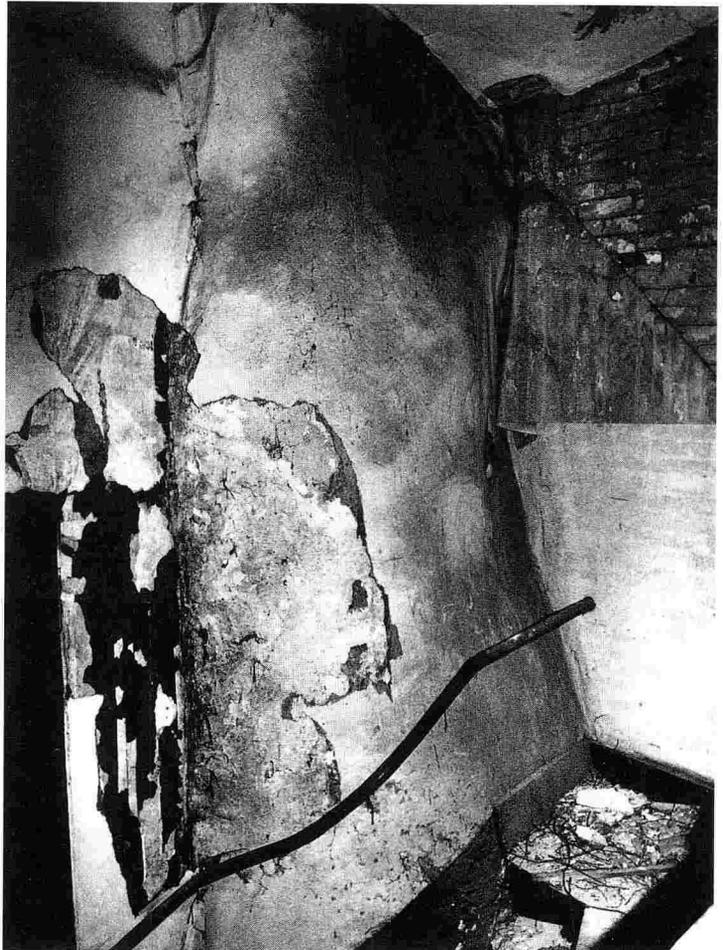
FIG. 31 – Mass of north-west respond of west tower hidden under plastered lathing in staircase of house No. 1 [*k* in Figs. 24B and 24C] (photo: author).

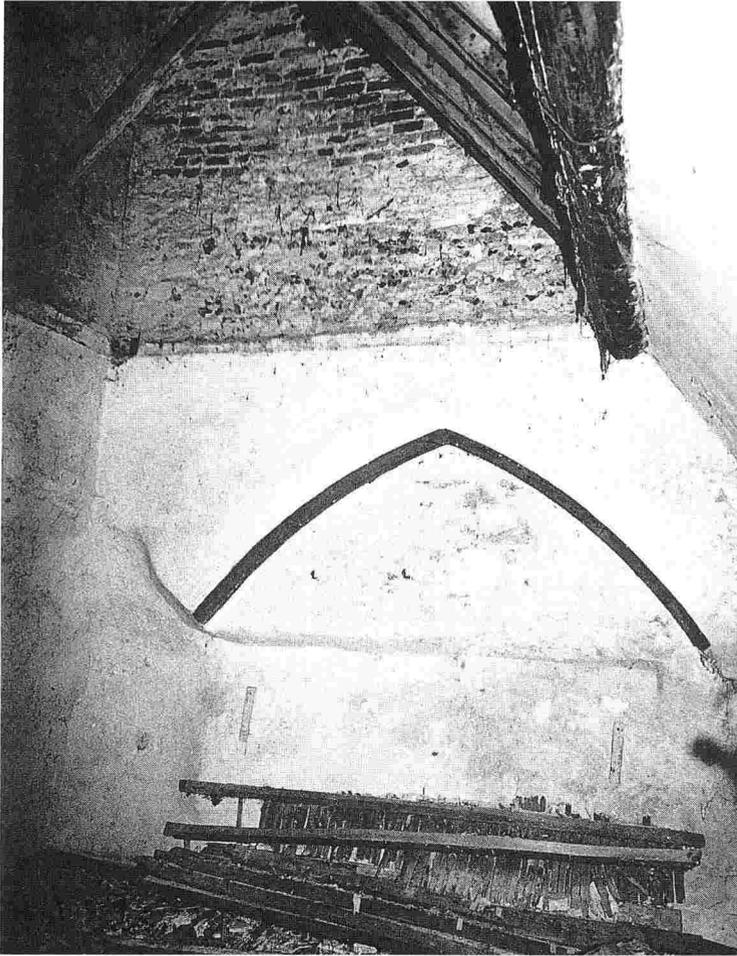
FIG. 32 – Westernmost arch of three 15th-century arches of north end wall of transept as seen inside attic room of house No. 1 [Fig. 24D, *m*] (*photo: author*).

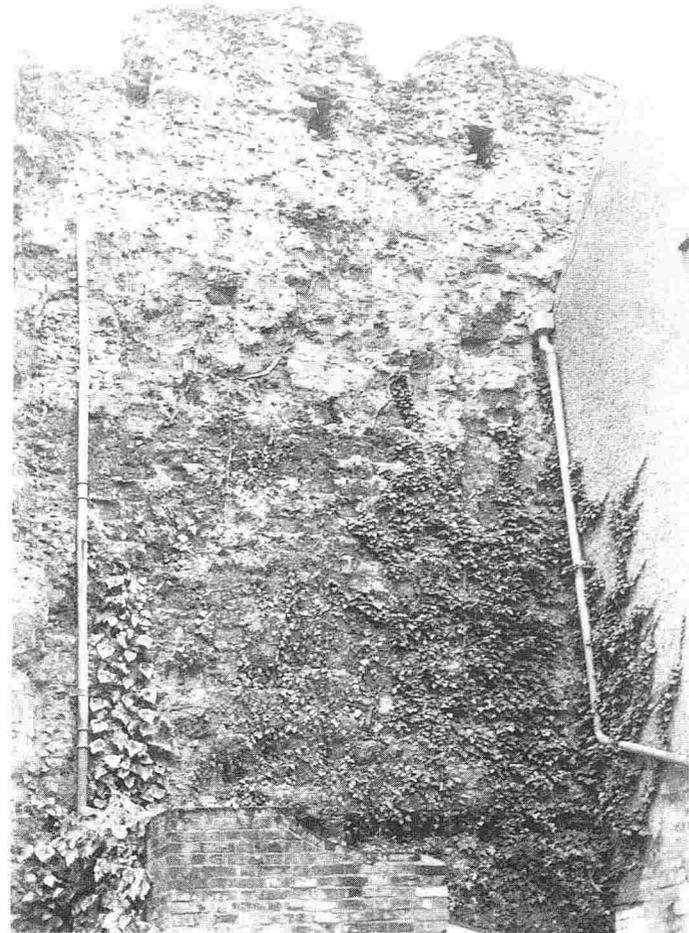
FIG. 33 – Eastern half of north face of south end wall of transept as viewed from garden behind house No. 2 (*photo: author*).

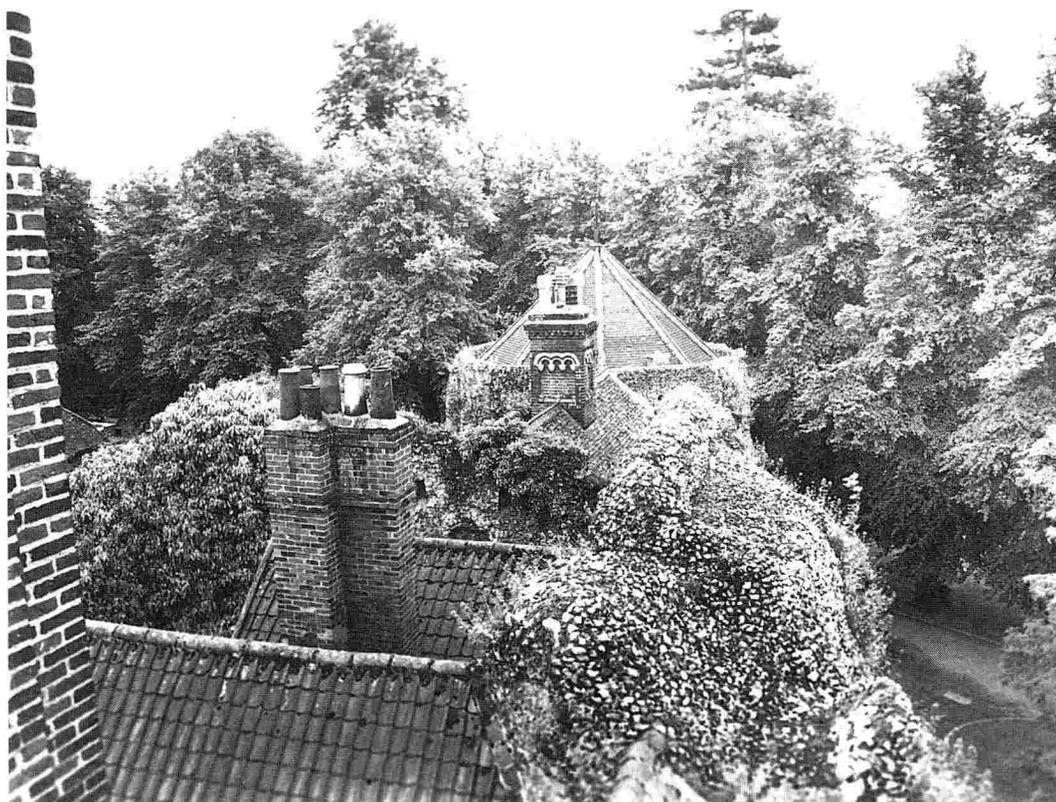
FIG. 34 – View over house roof tops to western half of south end wall of transept and south octagon (*photo: author*).

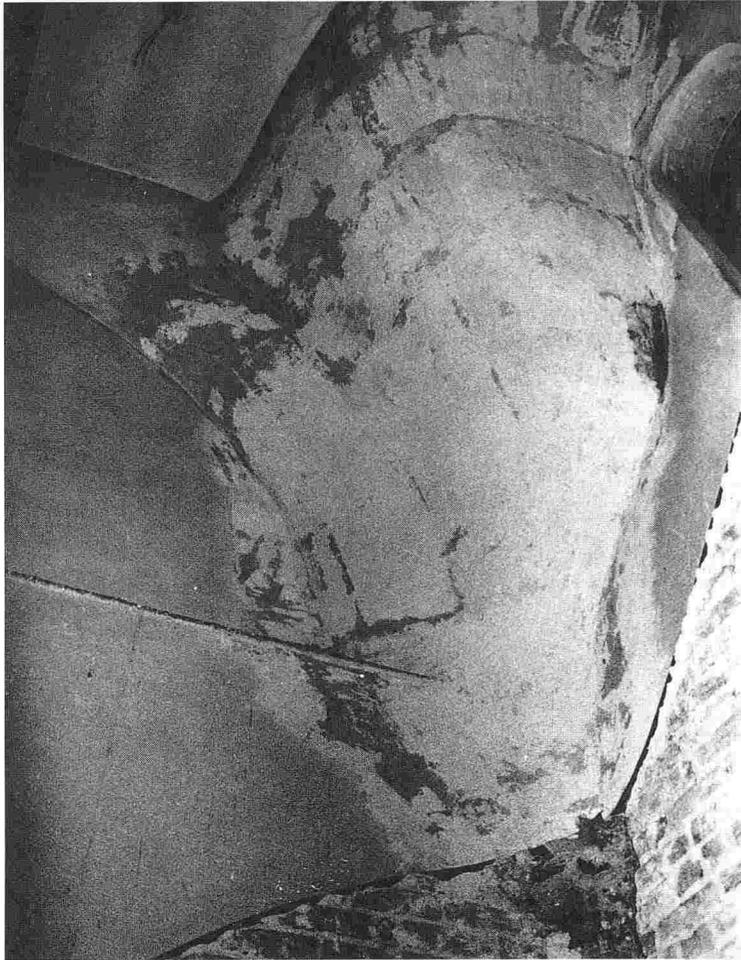
FIG. 35 – Springing of 12th-century groin vault inside house No. 3 at north-east corner [Fig. 24B, between t' and u'] (*photo: author*).

was two bays wide as well as two bays deep (Fig. 35). This would mean that there were four groin-vaulted bays forming the main body or nave of the chapel.

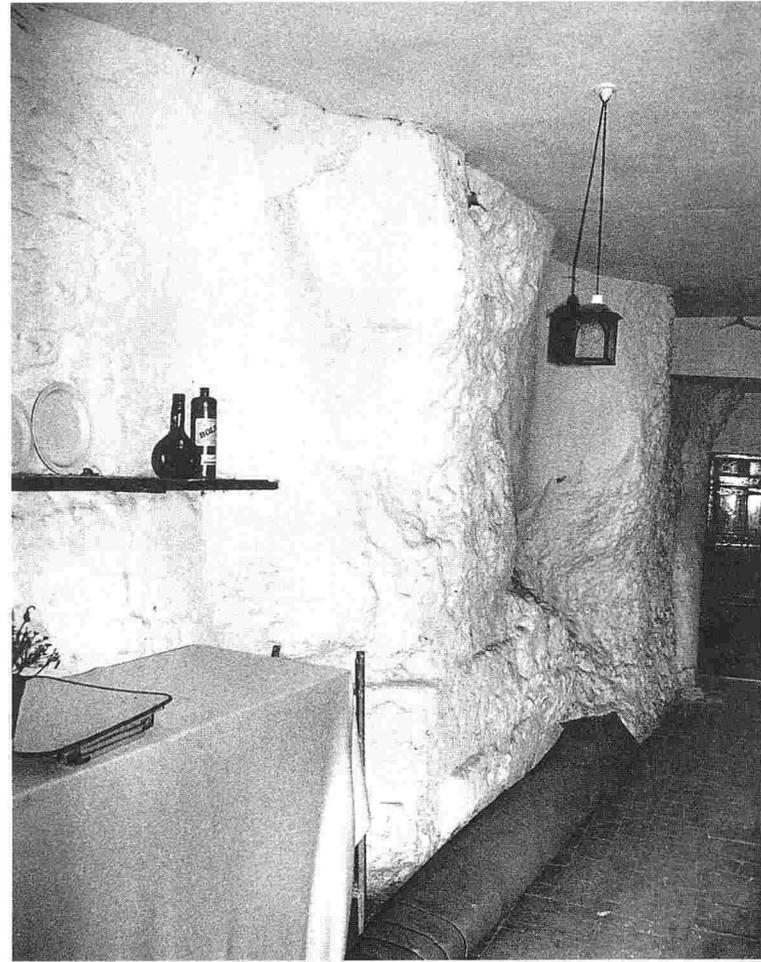
FIG. 36 – West side of blocked 15th-century arch, inserted in eastern arch between south chapel block and transept, seen from inside house No. 2 [Fig. 24A, v] (*photo: author*).

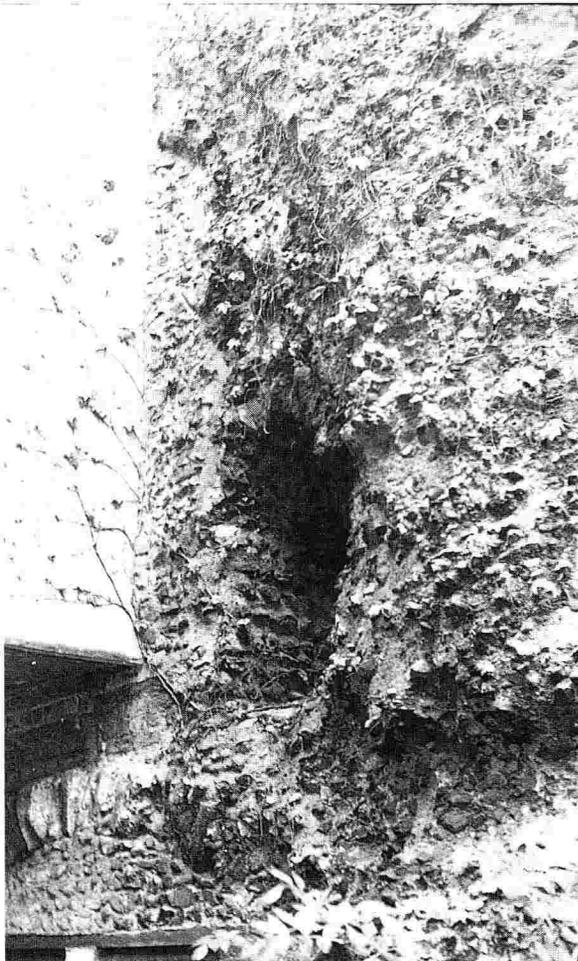
FIG. 37 – South face of north wall of north chapel block, with the short opening through the wall above the arch (lower left) of the former corridor leading to the (destroyed) northern octagon [Fig. 24A, x] (photo: author).
