Proceedings of the
SUFFOLK INSTITUTE
of
ARCHAEOLOGY AND HISTORY

Volume XXXVI Part 2

THE EXCAVATIONS ON THE SITE OF ICKWORTH MANOR

by WILLIAM FILMER-SANKEY, M.A., M.I.F.A.

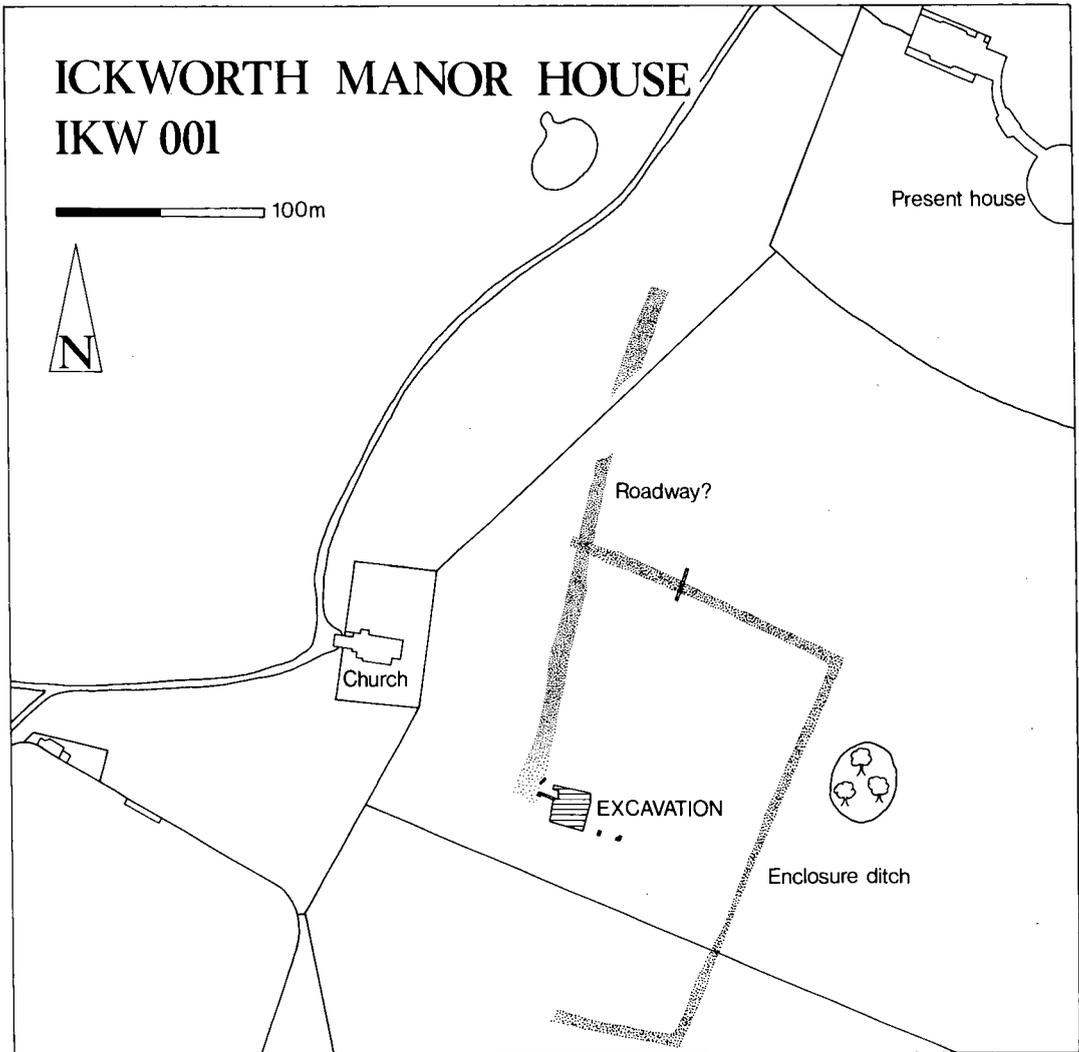
FIG. 9 — The location of the excavation.

A limited excavation (Fig. 9) was undertaken by the Suffolk Archaeological Unit, with the permission of the National Trust, in the spring of 1982 to locate the remains of the old manor and to assess their state of preservation. The excavation was principally an exploratory one to assess the potential of the site and was not primarily intended to provide evidence to supplement the meagre documentary record. A secondary aim was to throw light on the plan of parch marks in Manor Field, made by my great-great-grandfather Lord Arthur Hervey during the exceptionally dry spring and summer of 1844 (Hervey 1849), and on a rectangular enclosure showing on air photographs of the site (Fig. 9).¹

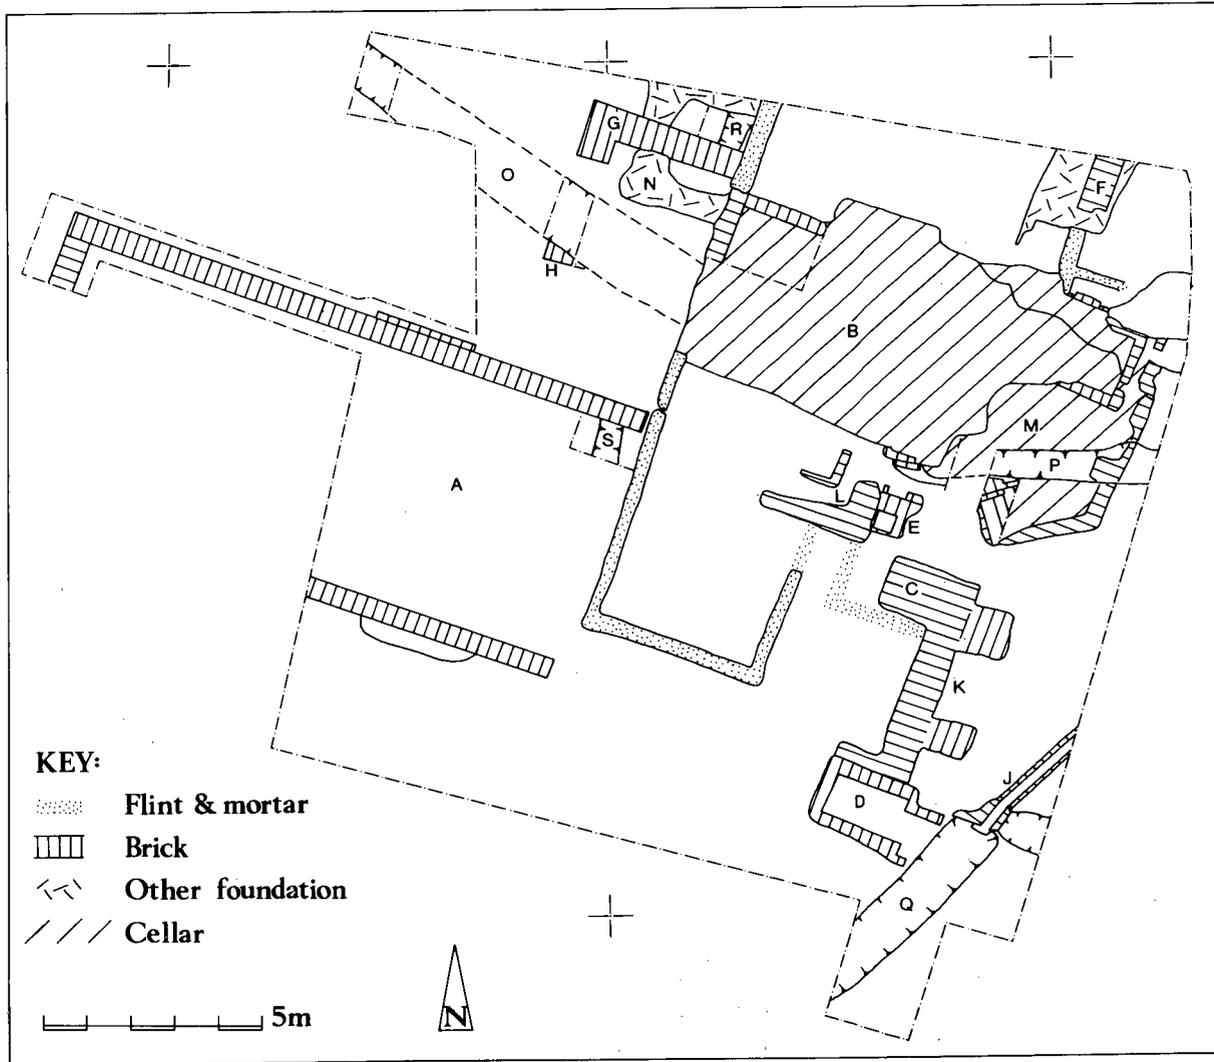
Fig. 10 — Interpretative plan of the excavation.

This earliest identified building was characterised by a number of insubstantial wall footings of large flints set in creamy mortar which were revealed when the area was cleaned (Fig. 10). As they were only 30cm wide and *c.* 25cm deep, it seems that they were dwarf-walls, designed to take the sill-beam of a timber frame. The surviving dwarf-walls do not form a coherent plan and it is possible that more remain to be uncovered, while others have been obliterated by later brick walls and cellaring. Some may even have been destroyed by ploughing.

The main brick addition was a wing, stretching west from the apparent end of the dwarf-walls and measuring 6.50m × 14m (Fig. 10,A). Its southern wall comes to an abrupt end in line with the dwarf-wall and it is possible that its line was continued to join with the chimney base/garderobe (Fig. 10,C,D) by a flimsier wall, which has been removed by ploughing.

A cellar, surviving to a depth of 1.20m, was inserted, stretching back from the main dwarf-wall, which was replaced by brick at this point (Fig. 10,B). None of the other walls of the cellar seem to have been carried above ground level. Access to the cellar was by a stair in its south-east corner and its floor was tiled with plain 13.3cm × 15.2cm floor bricks.

The substantial U-shaped foundation is best interpreted as a chimney base (Fig. 10,C). Butted up against the south side of this chimney base was a rectangular structure which limited excavation showed to have at least three courses of brick on its inner side, but only rubble on its outer face (Fig. 10,D). It was open at its eastern end, where it appeared to give into an open

A well-built drain was possibly a soakaway, as there was no sign of any channel leading to or from it (Fig. 10,E). A substantial wall apparently replaced a flint and mortar one (Fig. 10,F). Another substantial feature was an L-shaped footing, built onto the west side of the main north-south dwarf-wall (Fig. 10,G). It would seem to go with a fragmentary corner, which has been largely cut away by a later ditch (Fig. 10,H). This is probably the foundation for an entrance porch of early Tudor type. The actual foundation of this was made up of large pieces of limestone, some of which were architectural fragments. The largest was a piece of perpendicular tracery. These could have come from the nearby parish church, but it is perhaps more likely that they came from Bury St Edmunds Abbey, dissolved in 1539.

Finally, a brick culvert, probably covered with wooden boards, ran south-west through the wall line into an open ditch, next to the garderobe (Fig. 10,J). To the east of this drain the main wall had been robbed of its brick. The fact that the drain escaped this fate may mean that it was still in use when the house was demolished.

As well as these additions, a number of alterations to the brick structure can be distinguished. The most important of these was the blocking of part of the cellar. Its south-east corner, including the staircase, was carefully blocked off with rubble set in yellow clayey loam (Fig. 10,M). The walls of the blocked area, especially the topmost and facing bricks, were slightly, but not seriously robbed. The new entrance to the cellar was not located, but was probably at its eastern end.

The entrance porch was replaced by another, smaller one, set slightly further north (Fig. 10,N). Only its foundation of decayed limestone survived. Two buttress-shaped foundations were added to the back of the chimney and these probably represent the addition of a second, smaller, stack to the existing chimney (Fig. 10,K). A rough brick drain was added on to the side of the existing drain or soakaway (Fig. 10,L).

Nevertheless, a number of phases of development could be distinguished. The earliest of these consisted of two short lengths of ditch (Fig. 10,R,S), both *c.* 50cm wide and 50cm deep

In addition to this there were several features which could not with certainty be attributed to any phase. Chief of these was a ditch (Fig. 10,O), which postdated the construction of the earlier tower porch, much of which it totally cut away, but predated the robbing of the cellar. At its eastern end it was only c.30 cm deep but, by the time that it disappeared under the western edge of the site, it was at least 1.75m deep, with sheer sides cut into the natural clay and backfilled with only slightly mixed natural clay. It produced few finds and its purpose remains a mystery.

Equally defying interpretation was a trench, with a square profile, 60cm deep (Fig. 10,P). It postdated the blocking of the south end of the cellar and ended near to the end wall of the modified cellar. It was filled with compact gravel and so may have had a structural function.

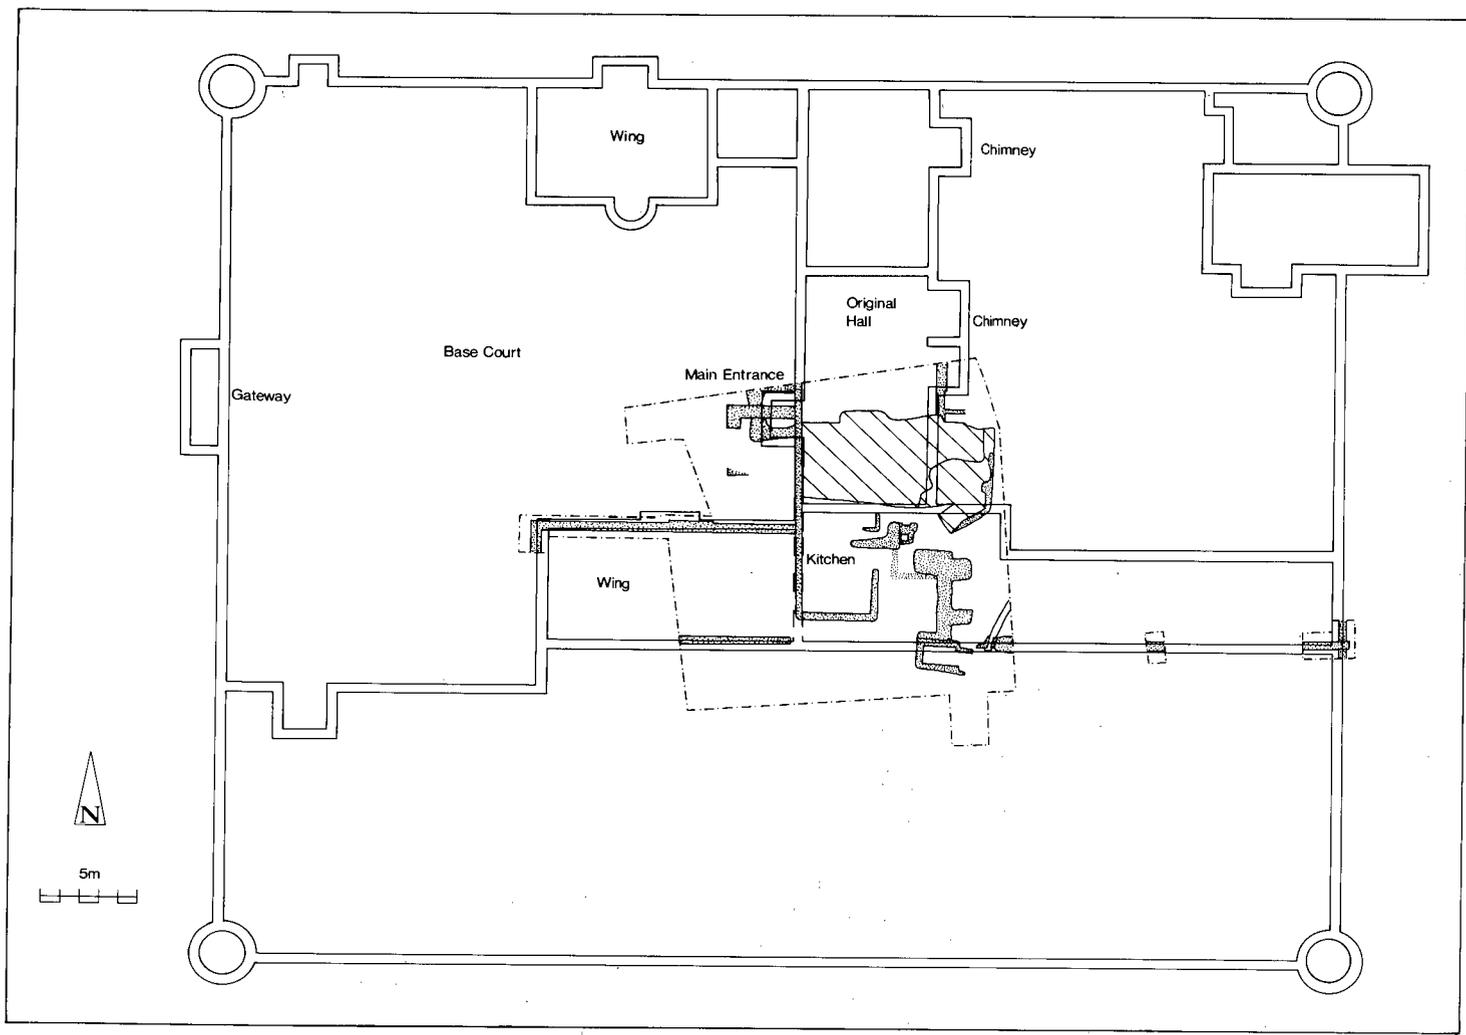
FIG. 11 — An interpretation of Lord Hervey's 1844 plan with the 1982 excavation superimposed.

It proved possible to locate our plan on to Lord Hervey's 1844 plan of the parch marks and thus to confirm its general accuracy, though it is wrong in some details (Fig. 11). Combining the evidence of the two, it is possible to interpret tentatively the overall plan of the house. Our excavation seems to have picked up the south end of the main façade of the original hall, and possibly the service end. From this original half-timbered hall there projected two asymmetrical brick wings, with chimneys and garderobes along the back walls, giving the house a U-plan. The entrance, slightly off-centre, perhaps to line up with the original screens passage, was a tower porch. In front of the house one can perhaps see a base-court, while the rectangular foundation on the west side of what is probably a surrounding wall, could well be interpreted as a gateway, similar perhaps to that at Erwarton Hall (Sandon 1977, 134, Pl. 75).
