PURTON GREEN, STANSFIELD: SOME LATER OBSERVATIONS ON THE EARLY AISLED HALL

by J.L. WALKER

SUMMARY

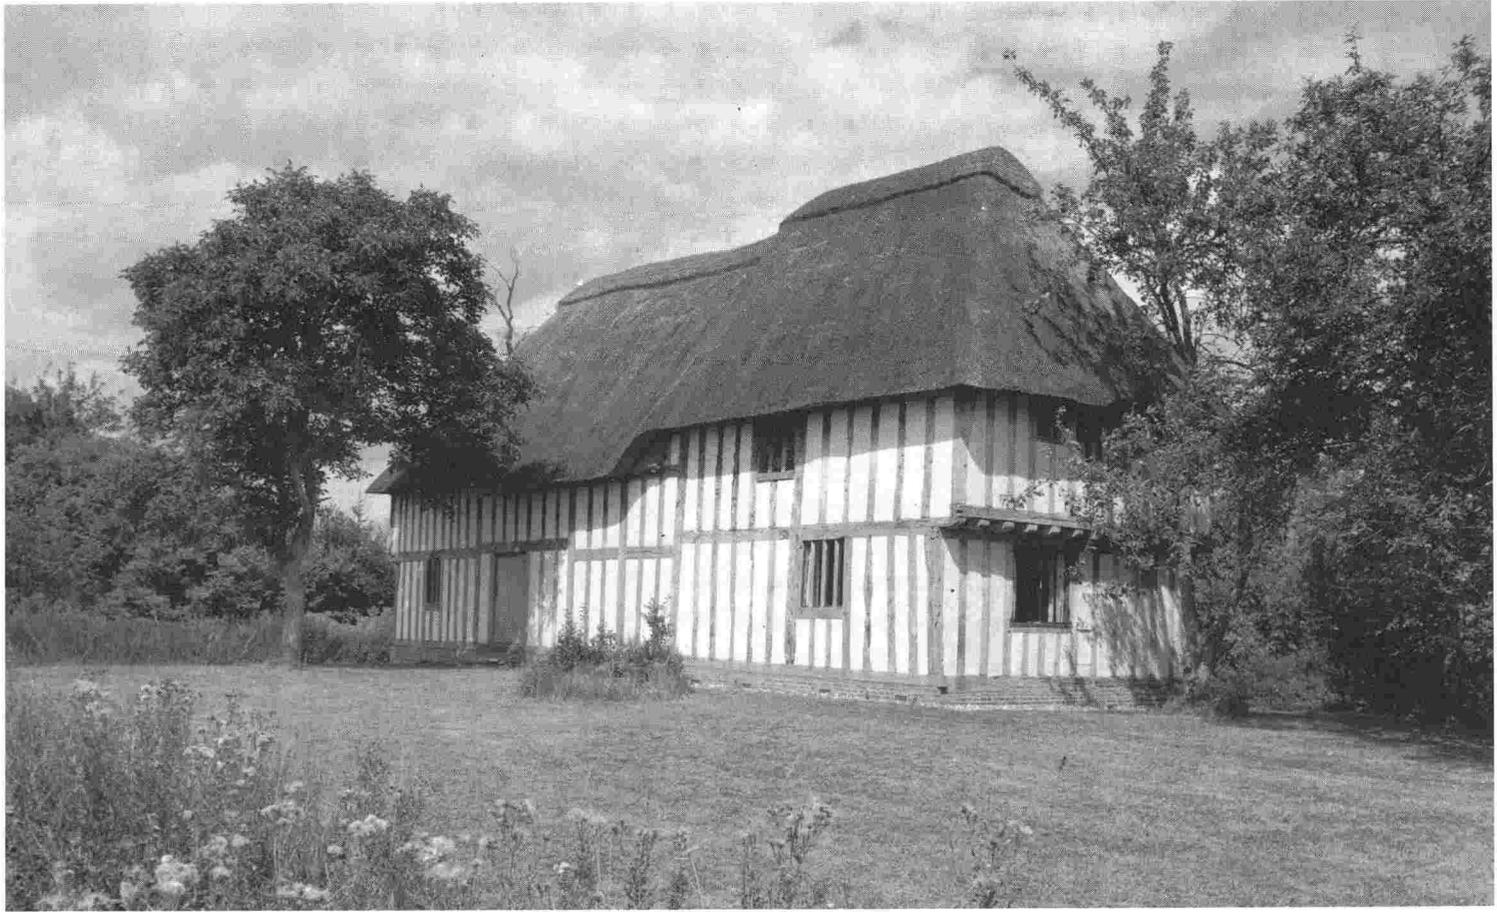
PLATE VII – Purton Green: the west front (photograph by Richard Hayman, reproduced by permission of the Landmark Trust).

THIS PAPER MAKES a few further observations on the structure and development of the 13th-century timber-framed aisled hall at Purton Green (Pl. VII), adding to the description by George and Sylvia Colman in these *Proceedings* (Colman 1965, 149–65). Briefly, this building has surviving in its centre just over one bay of an early aisled hall consisting of the open truss of the hall and north of this a closed truss, both of which have passing braces. The arcade plates of the aisled hall continue north of the closed truss though the rest of the building north of this truss was rebuilt in the 15th century. South of the open truss the arcade plates continue for about half a bay, but beyond that the rest of the building was rebuilt in the 16th century. At the time the Colmans surveyed the building it was in very poor condition and much of it was covered with plaster obscuring in particular much of the ground floor. Since then the building has been repaired, and most of the plaster removed along with some of the later features such as the floor that had been inserted in the open hall. This revealed, in particular, the lower part of the closed truss, the position of the aisle tie in the open truss and the position of an open hearth, all of which suggested a slightly different interpretation.

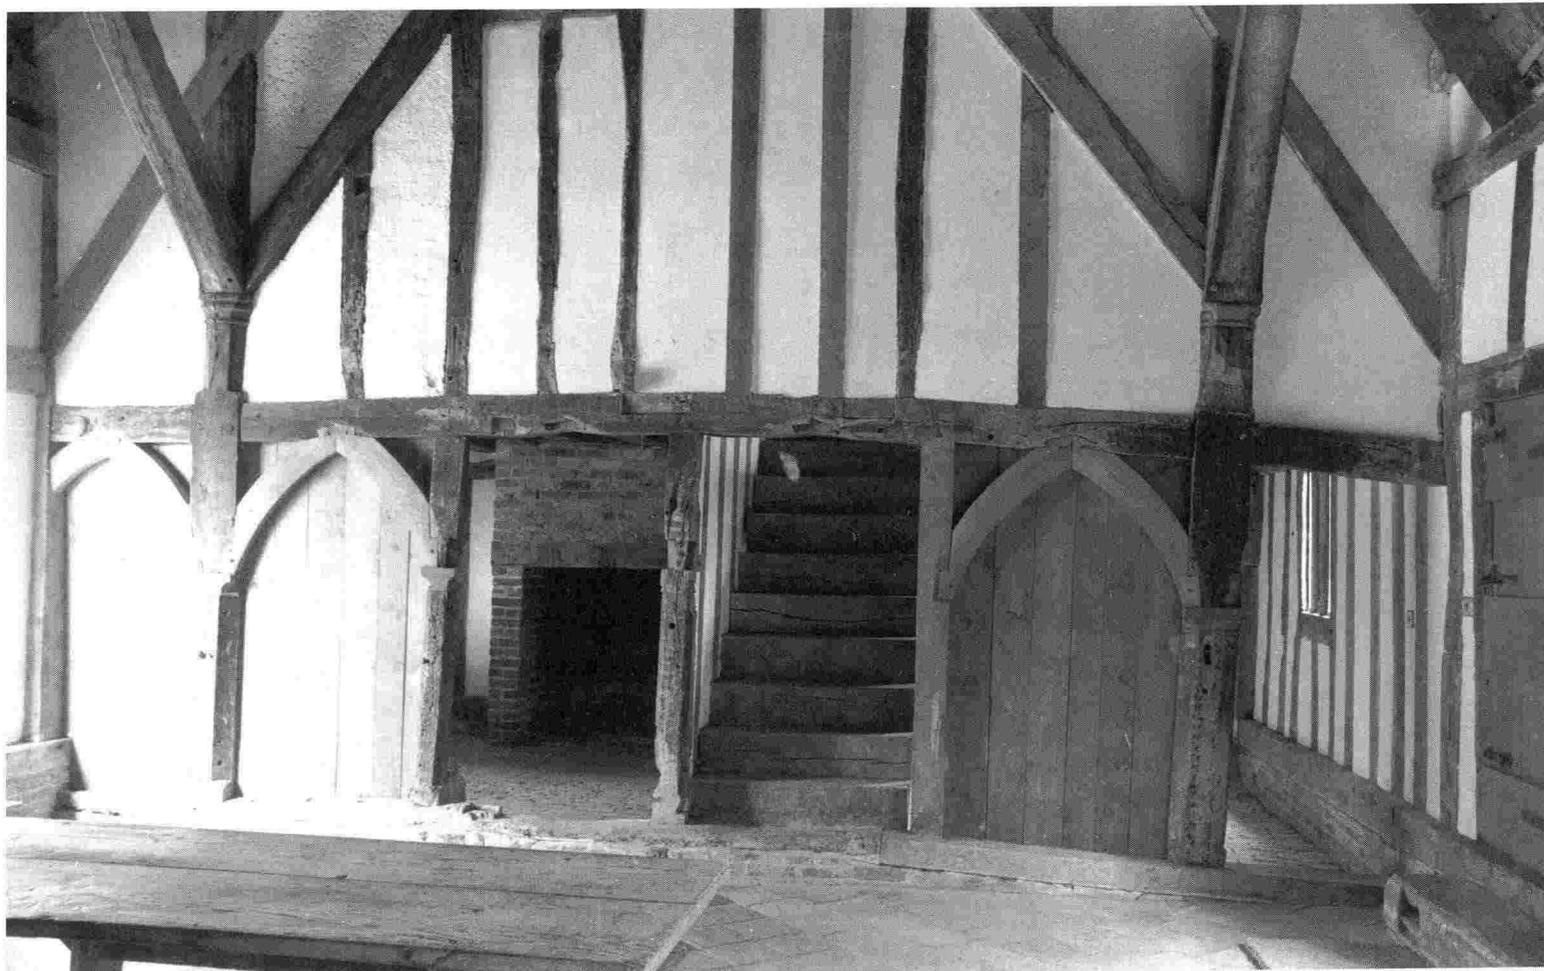
PLATE VIII— Purton Green: the low end partition at the north end of the hall, with most of the arches reconstructed (photograph by Richard Hayman, reproduced by permission of the Landmark Trust).

When the plaster was removed from the closed truss to the north of the hall the latter was found to be very decorative, with a continuous series of six arched openings along the ground floor (Fig.32 and Pl. VIII). It also showed that the aisles had originally been wider. All the arches had been removed but they can be reconstructed from the trenches and chamfering on the rail and posts (Fig.33). As those at each end of the truss originally finished outside the present side walls, it is clear that the aisles were originally wider. There is clear evidence that this narrowing occurred in the medieval period. This is because it involved removing the
