RESTORATION OF A XVI CENTURY FARM HOUSE IN SUFFOLK.

(Swan Green, Craftfield)

By ARTHUR WELFORD, A.R.I.B.A.

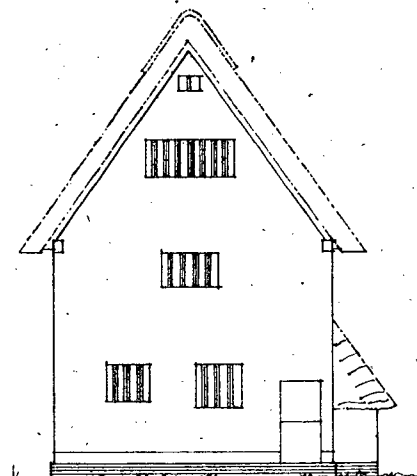
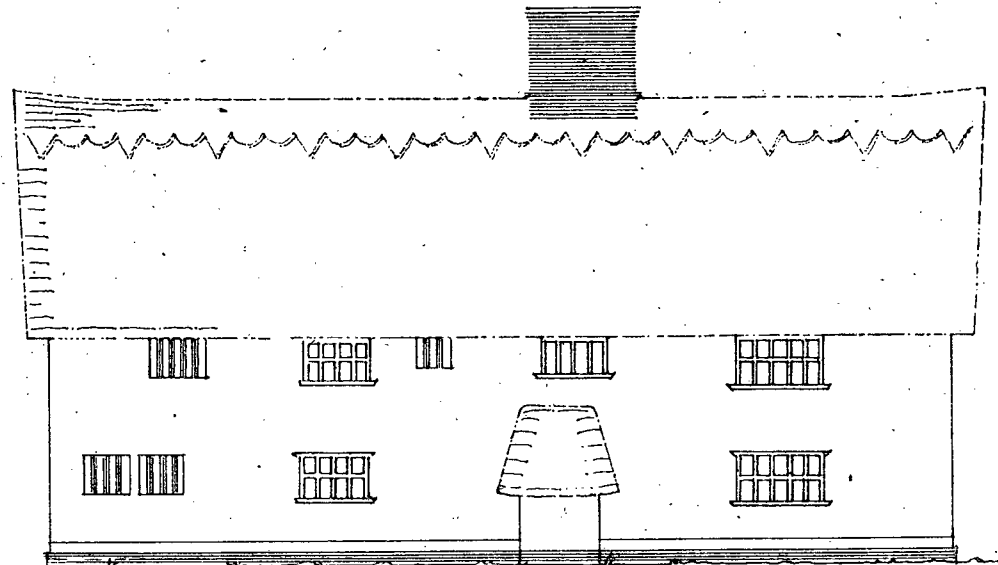
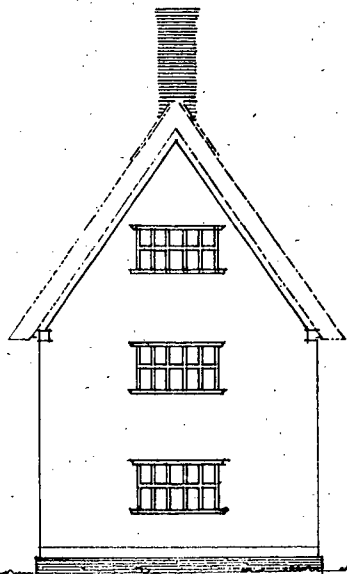
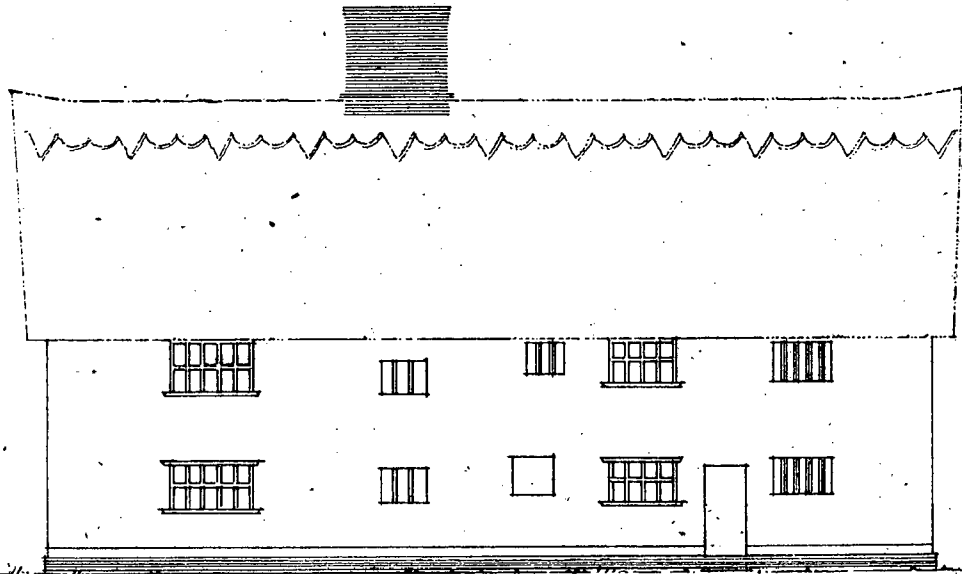
FIG. 4.

Fig. 4, shows the house as it appeared about 1580, and this is substantially how it appears after restoration (Plate III). It was not possible to replace thatch in 1940 so the pantiles were retained.

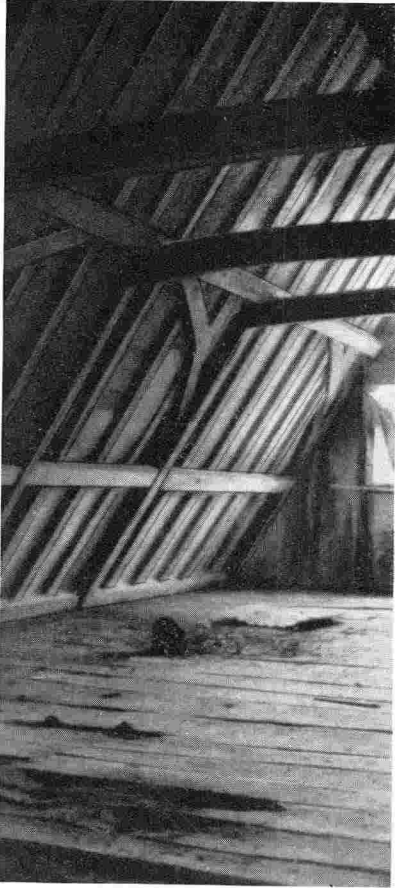
PLATE IV.

After Restoration.

Roof details.

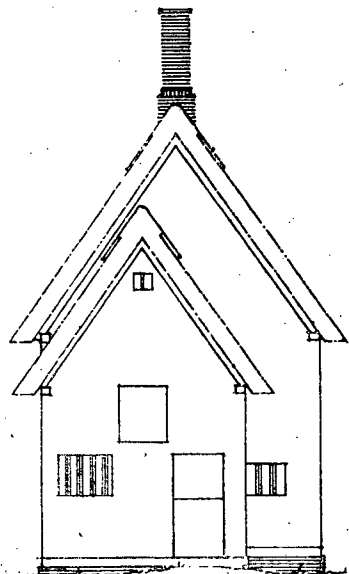
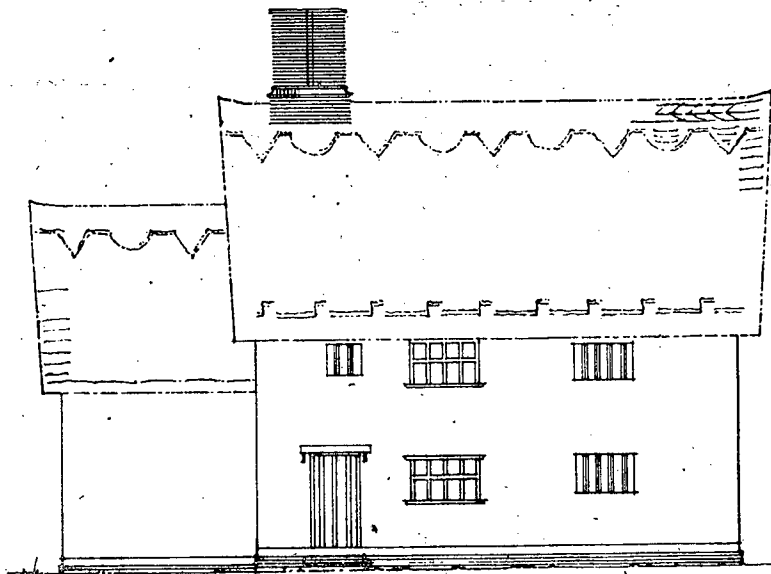
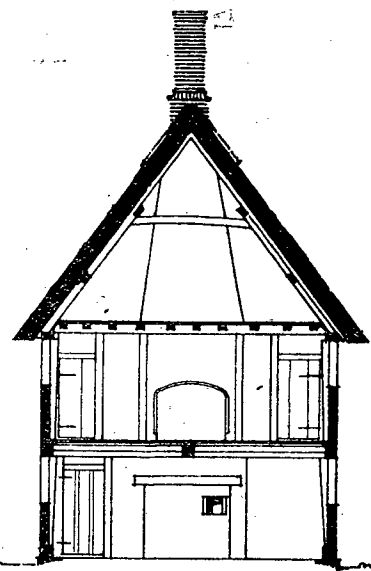
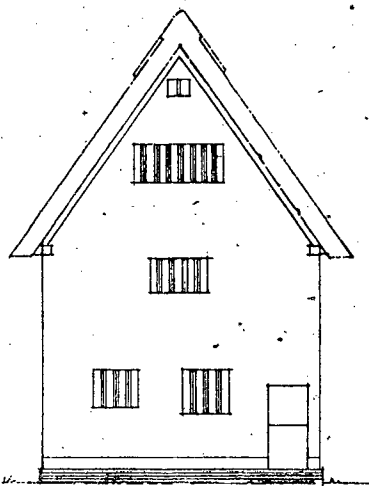
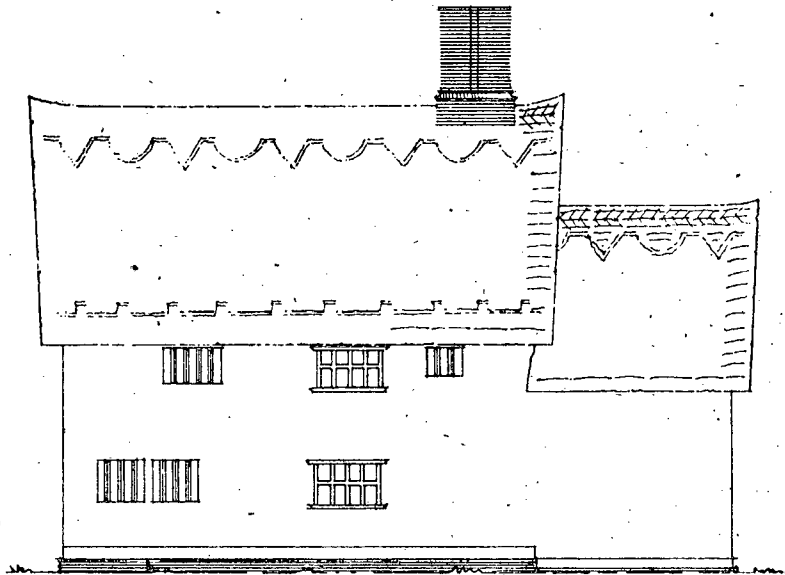
FIG. 6

The house was built at two separate periods; the first house (Fig. 5 and 6) may be dated about 1540. It consisted of Kitchen, Dairy, and Pantry; staircase, two bedrooms, and attic. A Byre is shown on the plan; although this is conjectural there is some evidence for it. A "diamond" mullion window, doorway, and some studding of the same period as the house were found incorporated in a stable at the NW end of the house—where they were obviously out of place—and there is the sawn off end of a roof plate, at a lower level than the main house roof plate, fitted to the S angle post of the house.
