## ARCHITECTURAL DETAILS OF LINDSEY CHAPEL.

BY H. J. WRIGHT.

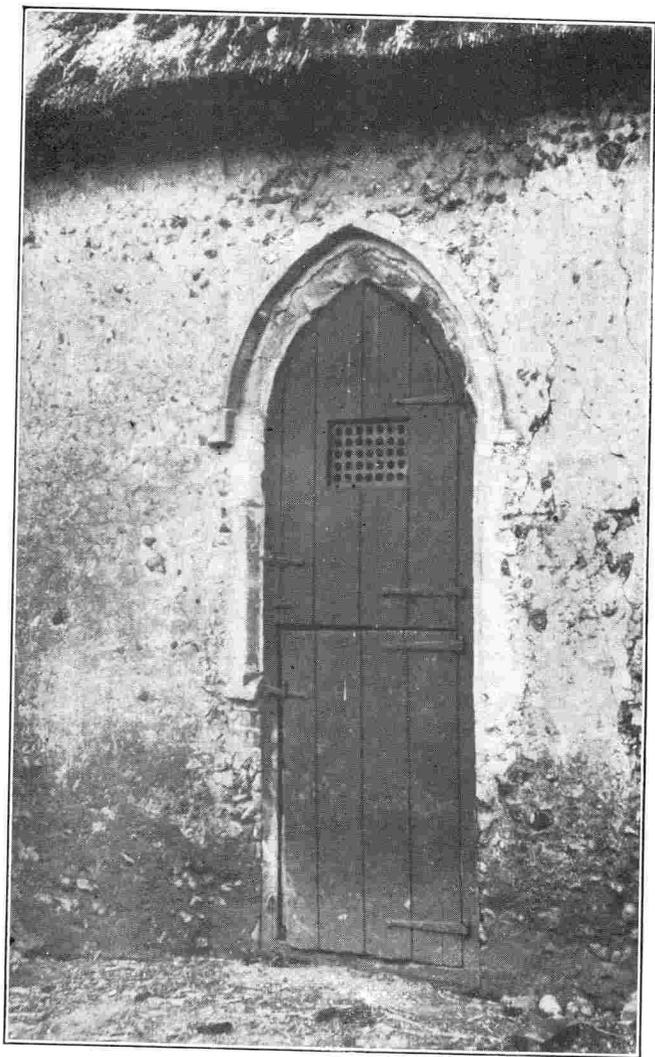
LINDSEY CHAPEL—ANCIENT NORTH WINDOW.

On the north side there were, originally, two windows, one of which has been bricked up and plastered over; the other, of a later date, has been converted into a doorway, the mullions and tracery have been removed, as well as the sill and wall beneath. Traces of the sill and cusping are visible.
