## TWO MORE DOVECOTES IN SUFFOLK

by JOHN MCCANN

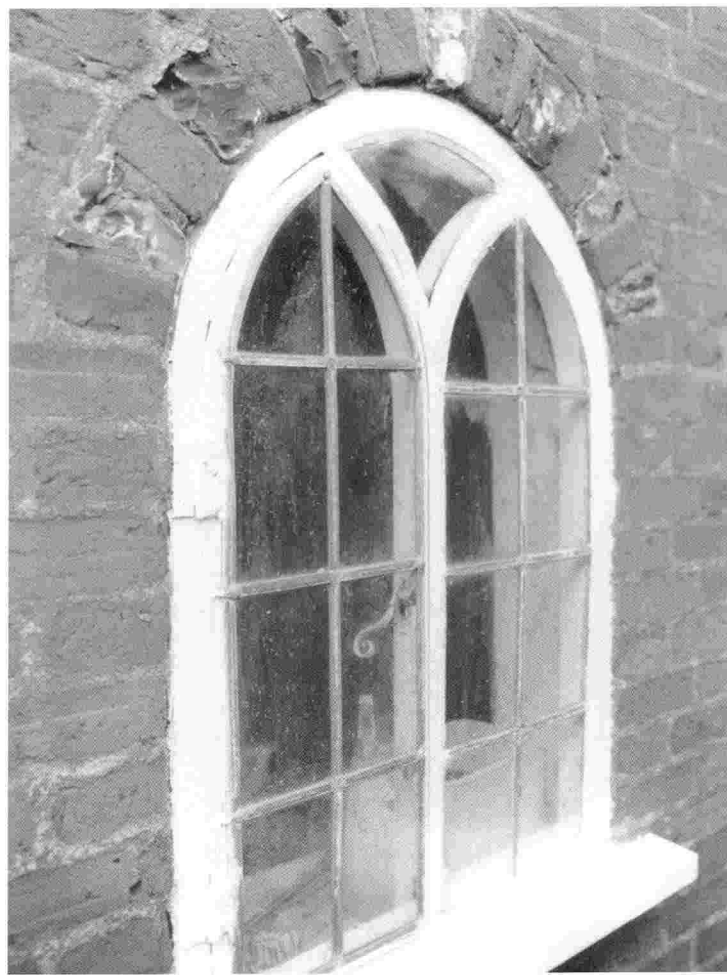
FIG. 127 – The ground-floor window at Stoke Ash.

In the lower storey there are two doors facing east and a window facing south, all mainly original. Both doors are six-panelled, 5ft 10in high by 2ft 1in wide. The window is 3ft high by 2ft 1in wide, with an elliptical arch formed of alternate bricks and dressed flints, with a couple of tiles included (Fig.127). The joinery with Y-tracery is all original, as is the wrought iron casement and fastening; only the hinges and leaded glass have been renewed. It is quite rare to find doors and windows of that period so unaltered. In the upper storey there is a ledged and boarded door 4ft high by 2½ft wide.

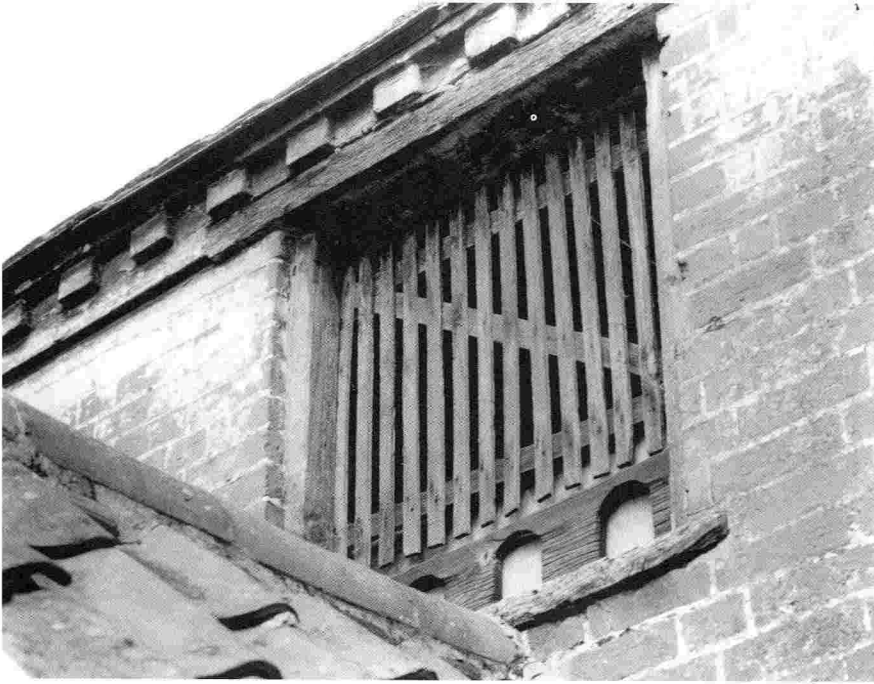
FIG. 130 – At Little Bealings this inserted aperture dates only from the introduction of the small-scale keeping of ornamental pigeons in the late 19th or early 20th century. Earlier the pigeons would have entered at a louver on the apex of the roof.

Doorways at both levels face north. The ground-floor doorway is 7ft 3in by 3ft 3in, with a segmental brick arch. A re-used six-light casement has been inserted, and the remainder blocked with brickwork. The first-floor doorway is intact, 5ft 1in by 2ft 6in, with a round brick arch and a simple ledged and boarded door shaped to the same profile. Originally the upper storey was accessible only by ladder. A later aperture 3ft square has been made in the brickwork to the rear (south), closed with a wooden grill, with four flight holes of inverted-U shape below (Fig. 130).
