SHORTER CONTRIBUTIONS

HAUGHLEY CASTLE

by Stanley E. West, M.A., F.S.A.

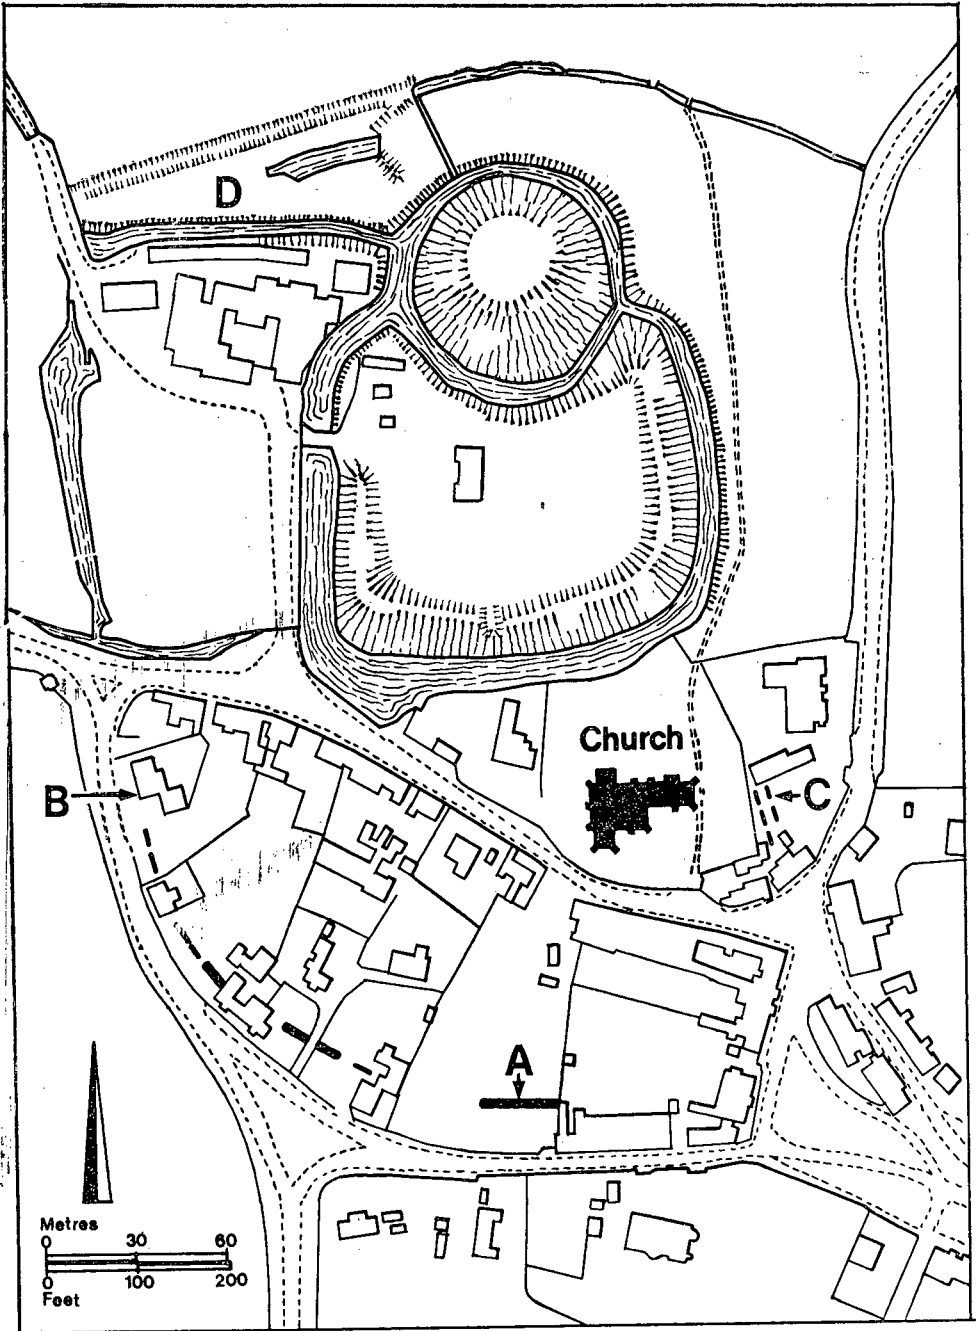
FIG. 15—Haughley Castle. A, dotted line indicates scarp of outer bailey; B, Fosse House; C, possible line of ditch; D, demesne enclosures.

The earthworks must, however, be seen in relation to the topography and layout of the village itself and not in isolation (Fig. 15). It is then that one is struck by the shape of the area to the south of the east-west route past the church and the castle. The road approaching from the south divides to join the through way on the west and the wide, wedge-shaped green on the east to enclose a large semi-circular area adjoining the south side of the castle. An examination of the gardens on the west and south of this curving line shows a small scarp or rise of 2–3ft all the way round, set back from the road edge. The scarp is first noticeable in the garden of the aptly named Fosse House (Fig. 15, B) close to the west entrance, becoming more obvious along the southern stretch, but is lost to the east, where it has been obscured by the development of the market (1227/8) and the green with the accretion of houses and shops on the presumed line of the outwork. However, in the gardens immediately to the east of the churchyard (Fig. 15, C) there is a deep hollow which could well be the infilled ditch, although there is now no sign of this joining the existing moat. The church would thus lie within the outer ward or bailey as at Lidgate. The continuation of the western line to the north strongly suggests that the moated area to the west of the castle is in fact a surviving part of this outer work and therefore contemporary with the castle. The ditches to the north of the main site may also be connected, delineating the demesne of the castle, and including the land to the edge of the sunken way on the east, now the road to Bacton, making the castle area a more complex but unified whole.

The object of this short note is to suggest, therefore, that the whole of this area was originally encompassed within an outer bailey and that traces of the surrounding bank and ditch are still discernible.
