TWO MORE DOVECOTES IN SUFFOLK

by JOHN MCCANN

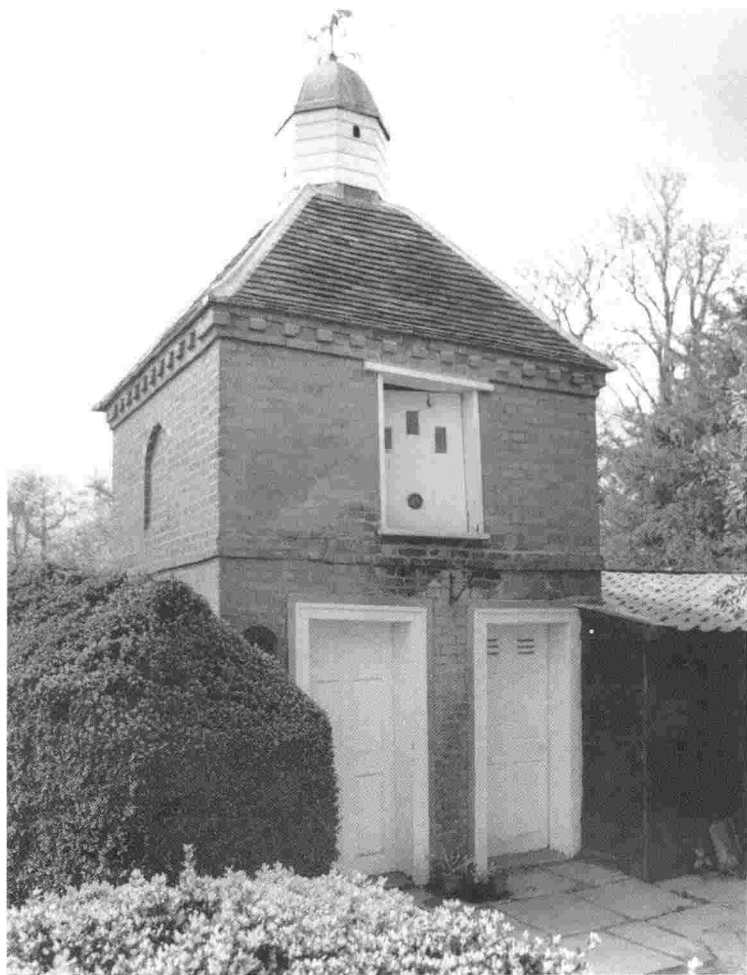
FIG. 126 – The dovecote at Stoke Ash from the east-south-east.

Stoke Ash is 8km south of Diss. 'Great Hallows' is the present name of the former Rectory, standing about 100m west of the parish church, approached from the main Diss-Ipswich Road. It is a house of early 19th-century appearance, though inside it proves to be a timber-framed house of medieval plan, altered and extended at various periods and clad with brickwork. The dovecote is 10m west of the service end, now hemmed in by ancient box hedges (Fig. 126).

It is a rectangular two-storey brick building facing east, 10 ft by 9ft, and 12ft high to the eaves. The lower storey was originally partitioned into two rooms for a privy and store, and is not very different now. The pigeon-loft occupies the upper storey, accessible only by external ladder. A later shed abuts to the north.

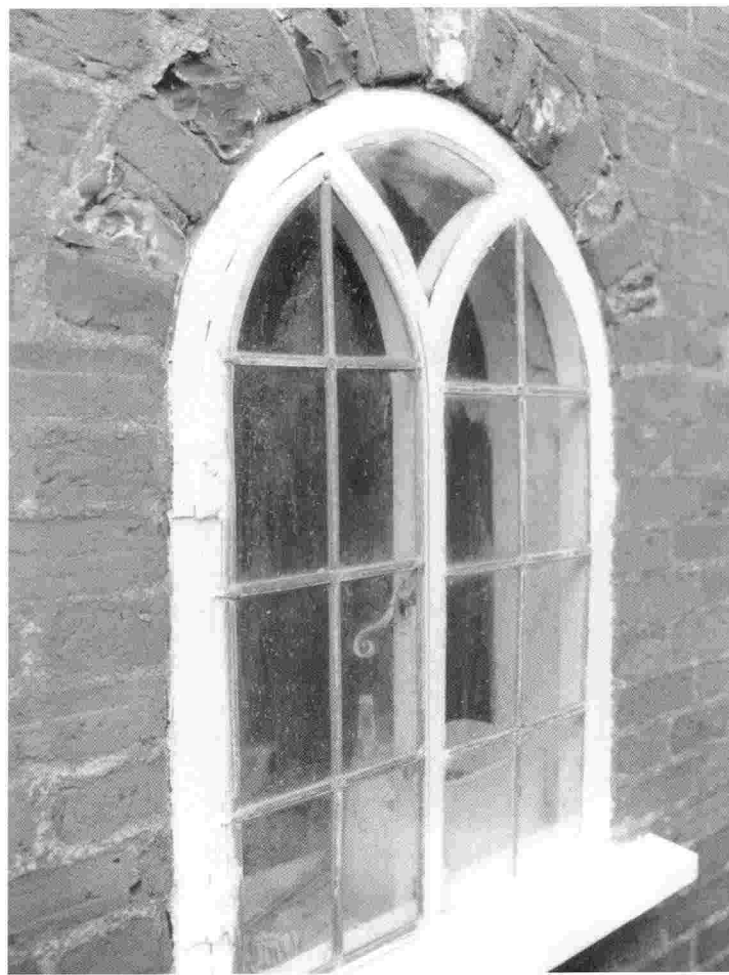
FIG. 127 – The ground-floor window at Stoke Ash.

In the lower storey there are two doors facing east and a window facing south, all mainly original. Both doors are six-panelled, 5ft 10in high by 2ft 1in wide. The window is 3ft high by 2ft 1in wide, with an elliptical arch formed of alternate bricks and dressed flints, with a couple of tiles included (Fig.127). The joinery with Y-tracery is all original, as is the wrought iron casement and fastening; only the hinges and leaded glass have been renewed. It is quite rare to find doors and windows of that period so unaltered. In the upper storey there is a ledged and boarded door 4ft high by $2\frac{1}{2}$ ft wide.

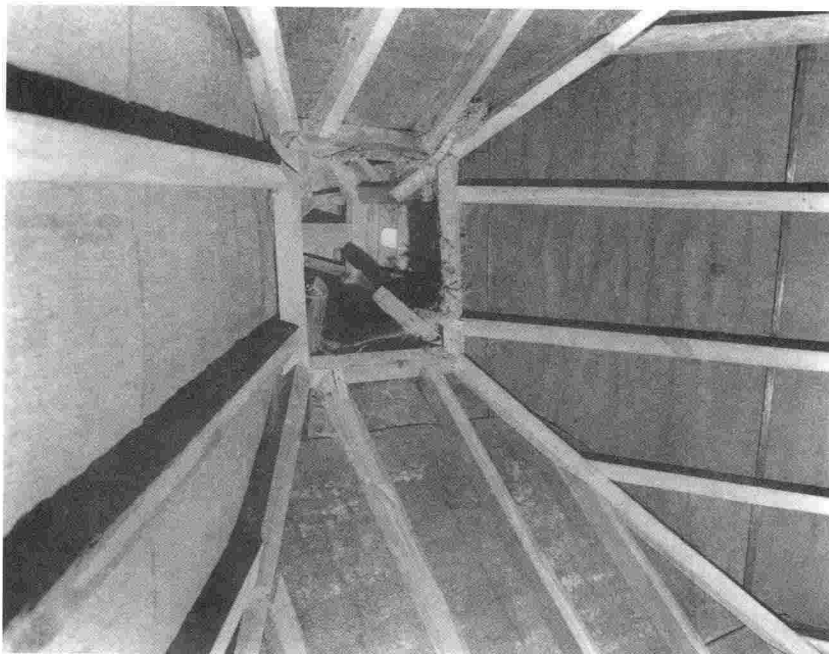
FIG. 128 – Looking up at the roof at Stoke Ash. The original hip rafters project into the square frame to prevent large birds of prey from penetrating to the interior. The octagonal louver itself has been renewed.

The rafters appear to be original, rising to a square frame which supports the louver (Fig. 128). The upper ends of the hip rafters project into the square gap through which the pigeons flew in and out. This may be a device to prevent birds of prey from penetrating to the interior, for the size of the frame is determined by the proportions of the louver. The original louver has not survived. There is no reason to doubt that, like the present one, it was octagonal with a domed lead roof.

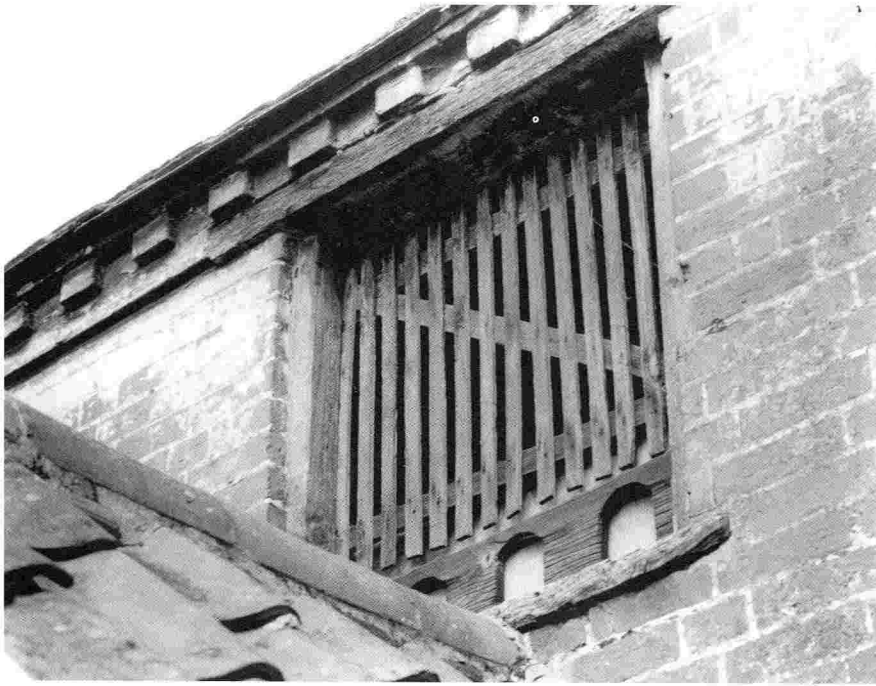
FIG. 130 – At Little Bealings this inserted aperture dates only from the introduction of the small-scale keeping of ornamental pigeons in the late 19th or early 20th century. Earlier the pigeons would have entered at a louver on the apex of the roof.

Doorways at both levels face north. The ground-floor doorway is 7ft 3in by 3ft 3in, with a segmental brick arch. A re-used six-light casement has been inserted, and the remainder blocked with brickwork. The first-floor doorway is intact, 5ft 1in by 2ft 6in, with a round brick arch and a simple ledged and boarded door shaped to the same profile. Originally the upper storey was accessible only by ladder. A later aperture 3ft square has been made in the brickwork to the rear (south), closed with a wooden grill, with four flight holes of inverted-U shape below (Fig. 130).
